Learning from Earthquakes

The M 6.3 Christchurch, New Zealand, Earthquake of February 22, 2011

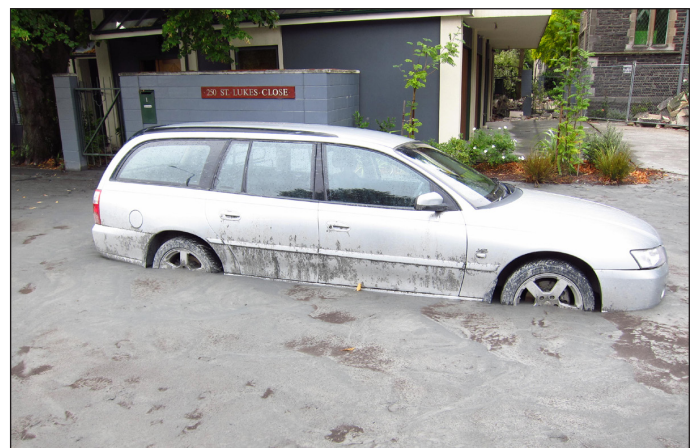
Figure 4. Severe liquefaction in the CBD (photo: Kam)

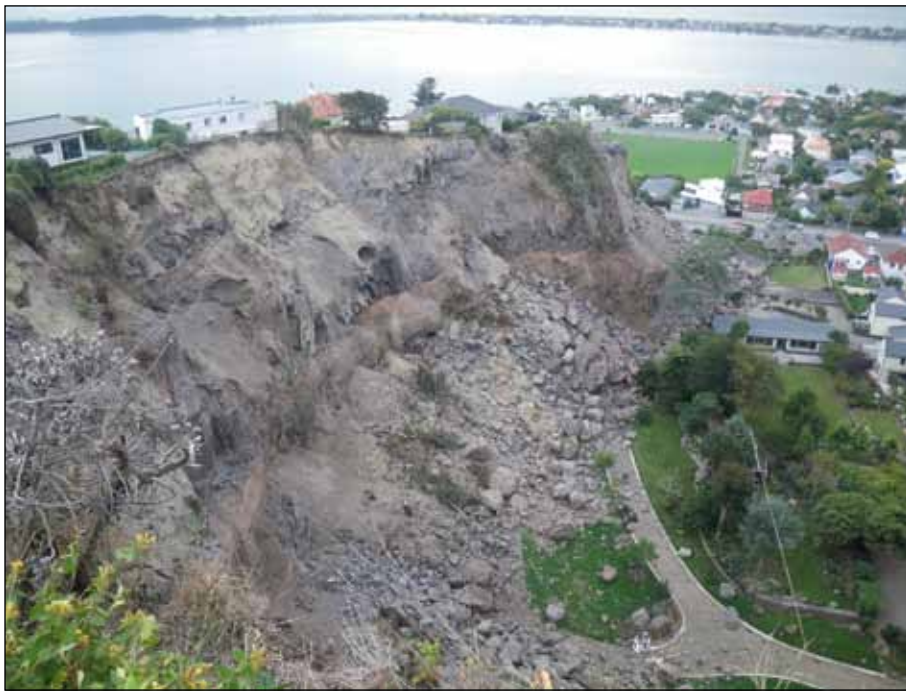
In some cases, entire cliffs collapsed (Figure 5), while in others boulders up to 5m in diameter were dislodged. Tension cracks 10-20m back from the cliff edges, often through residences, are being monitored. The prodigious rockfall was likely due, in part, to a number of source areas having been loosened in the September earthquake; furthermore, the February quake produced significant vertical ground accelerations as well as topographic effects that increased ground motions.

Figure 5. Large and damaging rockfall behind Moa Cave Guest house, Red-cliffs (photo: Mote).

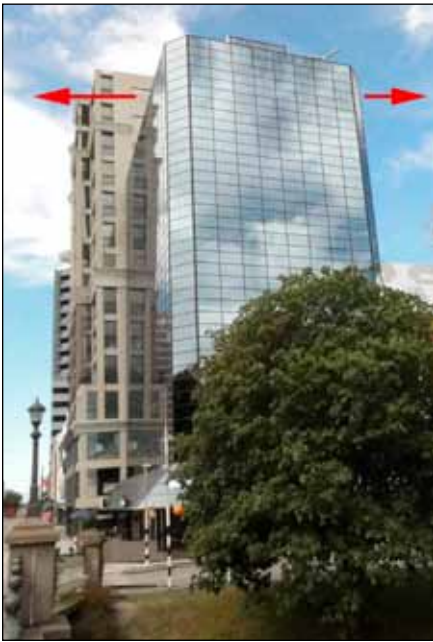
Figure 6. Differential movement of adjacent buildings (approximately 700mm at roof level) due to foundation rotation (photo: Elwood).

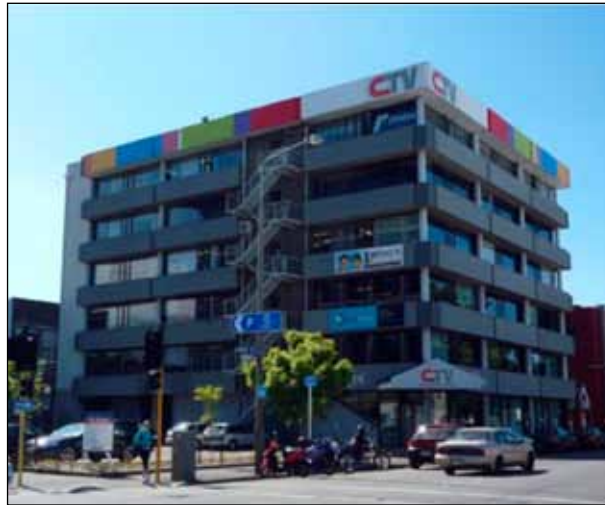
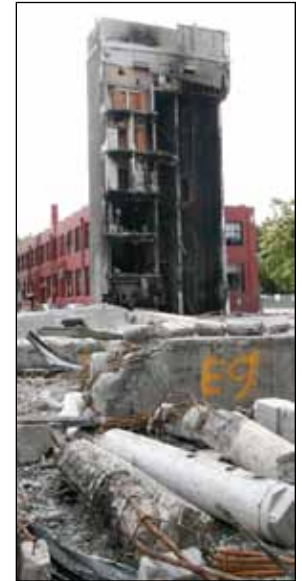
Figure 7. Collapsed reinforced concrete buildings: (a) ▲ The CTV Building and core wall (photos: Kam, Berkowitz); (b) ▼ The PGC Building (photo: Elwood).

Two reinforced concrete office buildings collapsed (Figure 7): the Canterbury Television (CTV) Building, which caused approximately half the fatalities in the quake, and the Pyne Gould Cooperation (PGC) Building, where 12 people perished. The six-story reinforced concrete CTV building was designed in the mid-1980s and consisted of a coupled shear wall on the south side and a core wall on the north side of the building. The entire building, with the exception of the core wall, collapsed (Figure 7a). The PGC building, designed and built in the early 1960s, was a five-story reinforced concrete frame building with a core wall offset towards the rear of the building. The top four stories collapsed onto the intact first story, with some floor slabs appearing to detach from the core wall (Figure 7b).

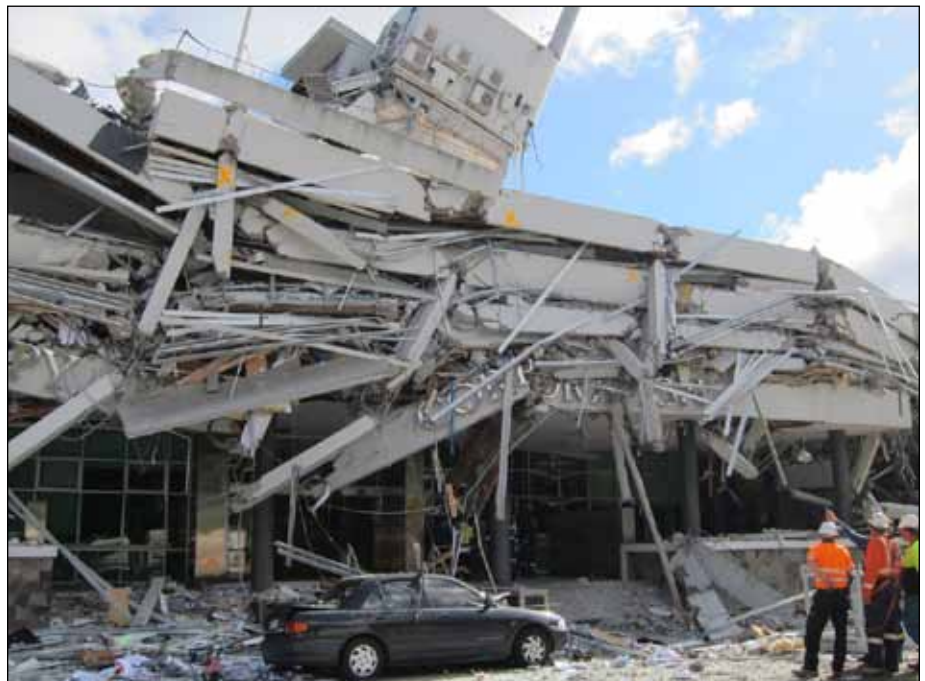
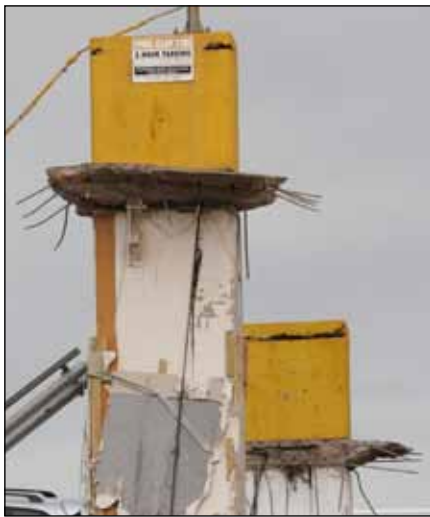
Figure 8. Punching shear failures in parking garage (photo: Berkowitz).

Punching shear failures of a prestressed floor slab resulted in partial collapse of a concrete parking garage at the south edge of the CBD (Figure 8). After the earthquake, a permanent twist and residual lateral displacement could be observed in the 19-story Hotel Grand Chancellor, one of the tallest buildings in Christchurch (Figure 9). The east side of the building cantilevered over an

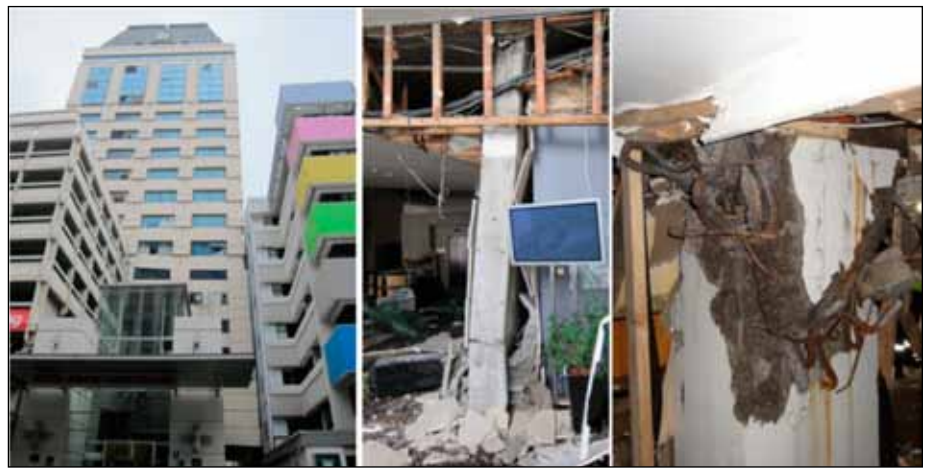
Figure 9. A permanent twist and residual lateral displacement in the 19-story Hotel Grand Chancellor (photos: Elwood, Comerio).

adjacent laneway by the means of transfer girders located on the seventh story, and out-of-plane shear failure was observed at the base of the wall providing the prop for the southernmost transfer girders. Three columns in the same grid line as the transfer girders on the sixth story also exhibited shear and axial failures. The building was surveyed for several days following the earthquake and the lateral displacement was not found to be increasing despite many aftershocks. The dam-

aged wall was stabilized within a week of the earthquake, but the building is now set for demolition.

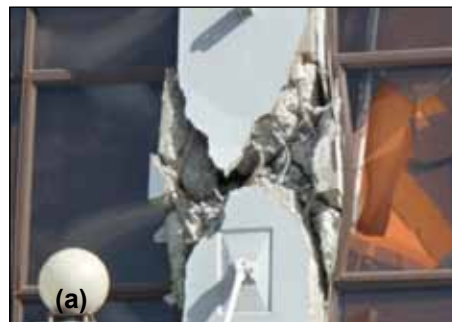
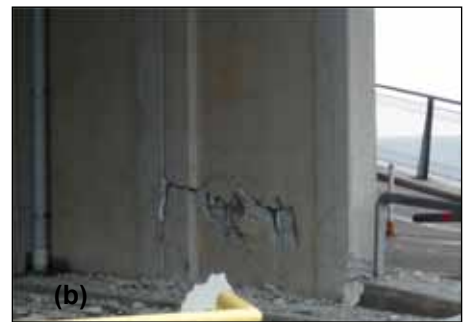
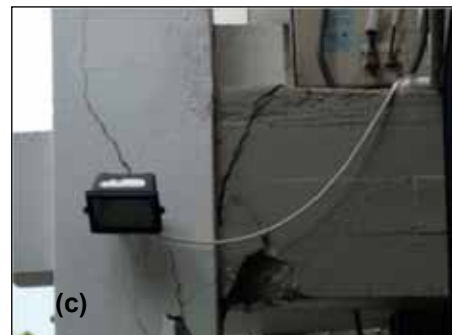
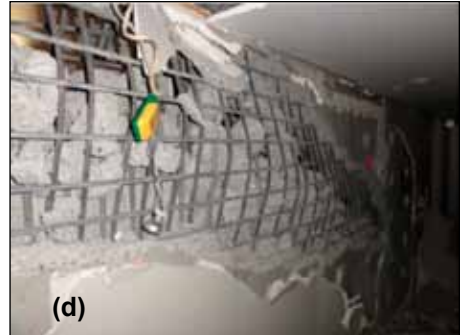
Figure 10. Examples of damage in concrete buildings: (a) column shear failure, (b) precast wall damage, (c) beam-column joint, (d) wall damage (photos: Sritharan).

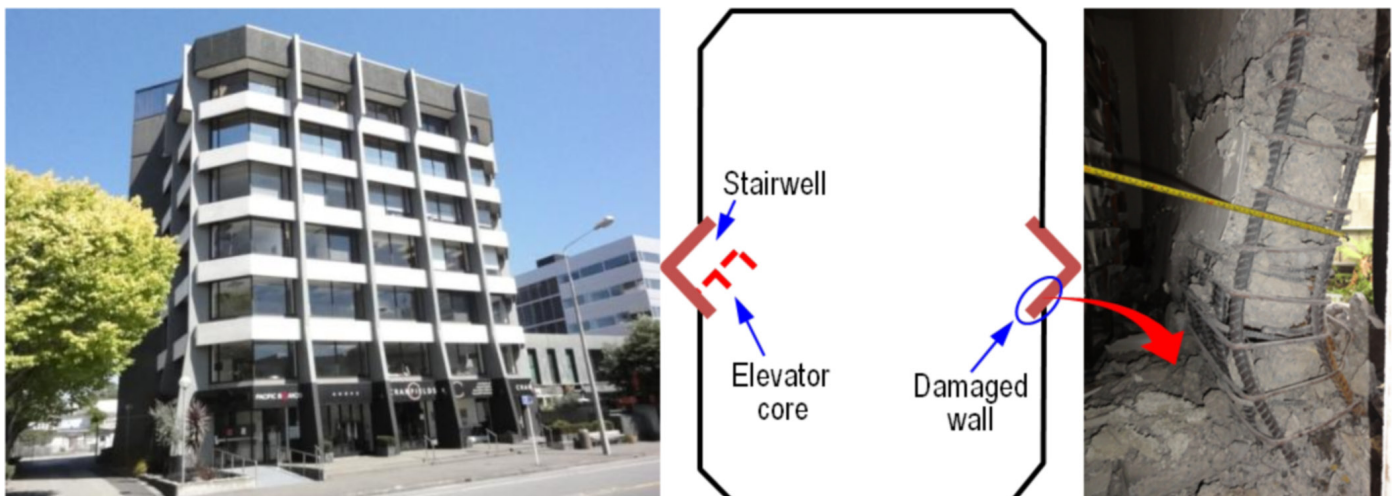
Figure 11. Damaged wall with good reinforcement details (photos: Sritharan, Elwood).

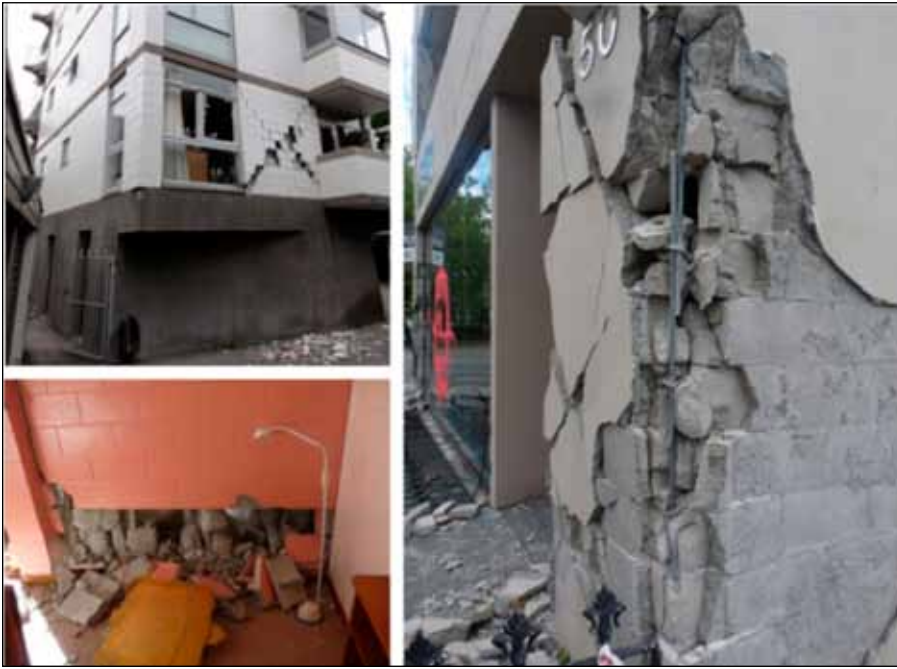
sitating demolition. Typical damage included shear failure of walls and failure of walls and columns due to poor grouting of reinforcement within the masonry cells (Figure 12).

Figure 12. Examples of reinforced masonry damage in multi-story buildings (photos: Jaiswal and Sritharan).

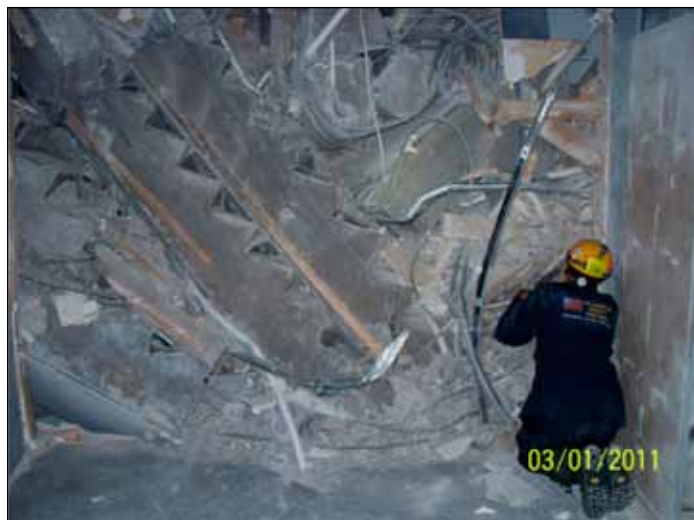
Figure 13. Collapsed precast concrete stairs in multi-story building (photo: Carri).

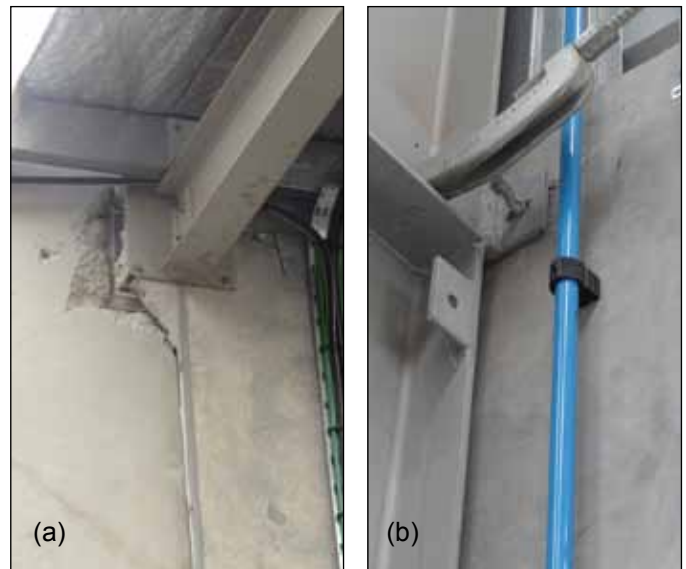
Figure 14. Damage to industrial buildings at steel-to-concrete connections: a) roof beam-panel connection in load-bearing tilt-up building; b) steel frame-panel connection in building with nonload-bearing concrete panels (photo: Marshall).

one foot (Figure 14a); note the absence of a continuous ledger at the diaphragm to concrete panel connection. On the west wall, the panels had cracked near midspan and deflected outward six inches.

In several buildings with steel frames and concrete precast panels, flexibility of the steel frame relative to the concrete panels likely resulted in failure of the connection between the frame and precast panels (Figure 14b). In one case, 12 wall panels dropped from a single warehouse. Typically, the end wall panels cracked because they were stiffer than the steel frame.

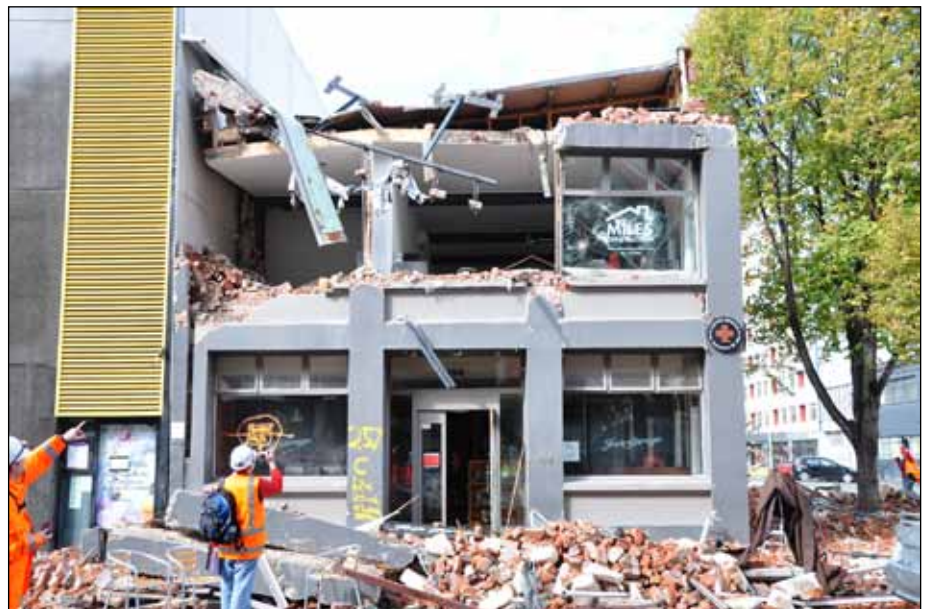
Figure 15. The EERI Team studies the performance of this heavily damaged, retrofitted URM building that pounded against the building on the left and partially collapsed (photo: Turner).

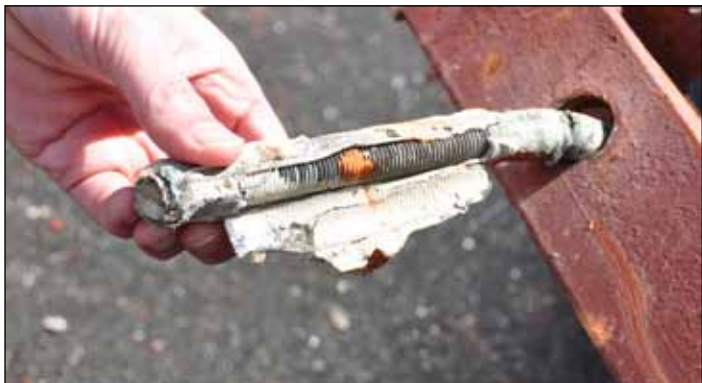
Most retrofitted URMs likely experienced ground motions well in excess of design motions, and in some cases, higher-than-maximum-considered earthquake motions, and their performances varied widely: 70% were red-tagged or cordoned to prevent public entry, 21% were yellow-tagged, and 9% were green-tagged. In many cases, prior damage in the September earthquake and the many subsequent aftershocks affected performance in February. Bond failures between anchor adhesives and masonry were prevalent (Figure 16), and low strength mortars also contributed to anchor failures.

Figure 16. This adhesive anchor at a URM parapet connection pulled out. A wire screen with white adhesive around the threaded rod had been inserted into a hole in the brick (photo: Turner).

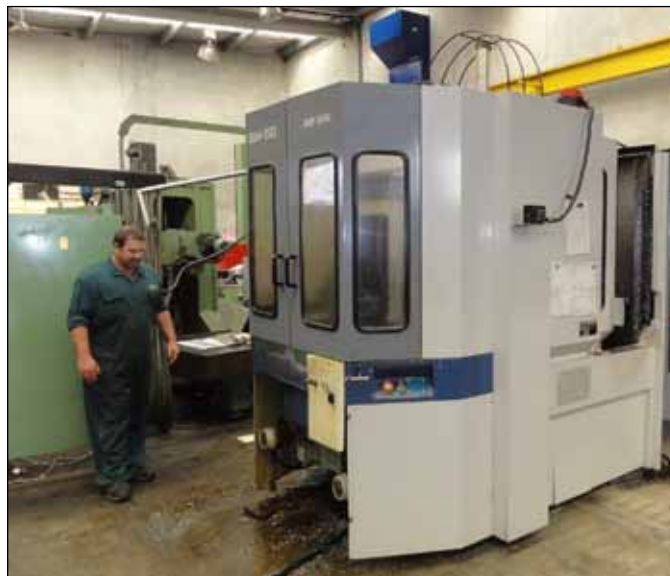
observed with substantial non-structural damage to critical equipment and supporting infrastructure. At one location, high vertical and horizontal accelerations moved 25,000-pound machining equipment about one meter from the original position, as shown in Figure 17. Workers at the facility described seeing the large equipment literally “bounce” across the floor. At a nearby textile facility, precision equipment was damaged by the ground motion; the misaligned equipment would have caused short-term production disruptions, but widespread liquefaction damaged the factory floor slabs and put the facility out of business for an undetermined period of time. As was the case in September, numerous storage rack collapsed in warehouses (Figure 18), necessitating the disposal of damaged goods.

Figure 17. Equipment weighing 25,000 lbs moved approximately one meter (worker’s foot indicates the original position of the equipment) (photo: Marshall).

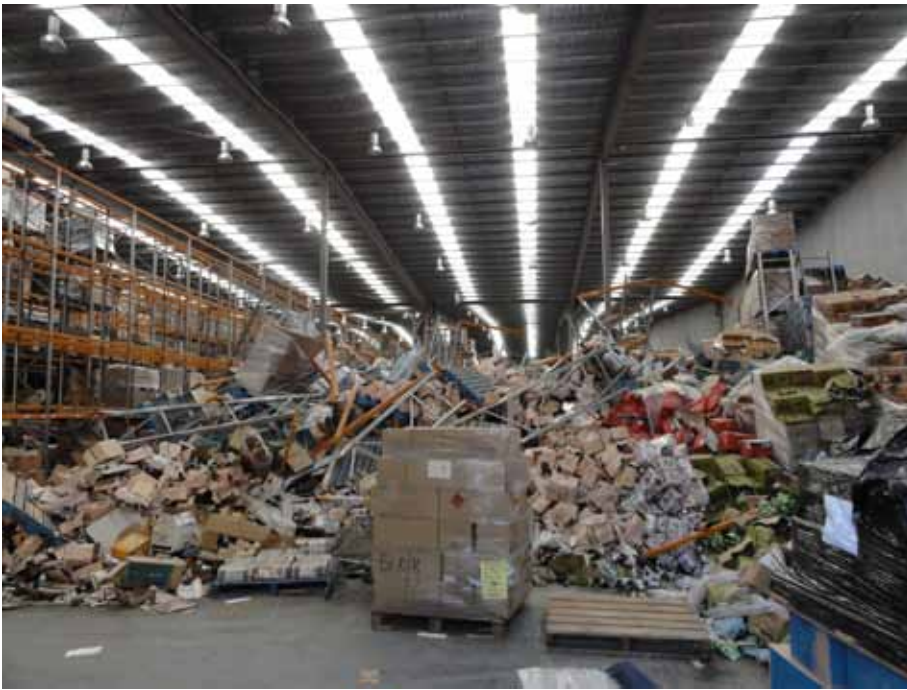
Figure 18. Collapse of storage racks (photo: Elwood).

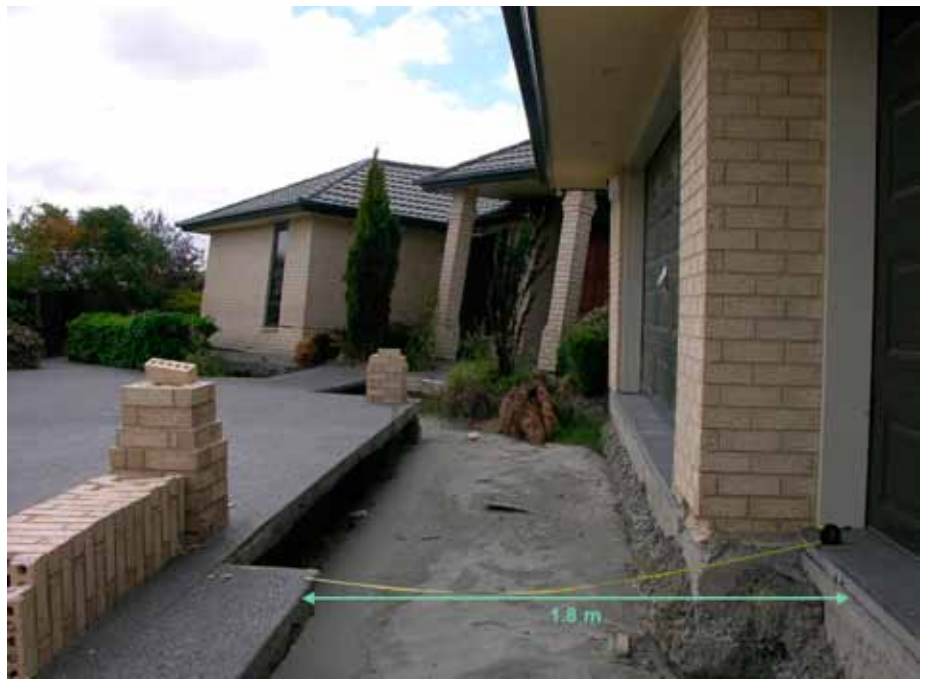
Figure 21. A house in Kaiapoi moved on its foundation in both the September and February earthquakes a total of 1.8m (photo: Lai).
