## Learning from Earthquakes

# The $M_w$ 7.0 Haiti Earthquake of January 12, 2010: Report #1

*This is the first of multiple Newsletter inserts on the Haiti earthquake of January 12, 2010. It summarizes observations from the advance team organized by the U.S. Geological Survey (USGS) and EERI that traveled to Haiti January 26 to February 3, 2010. The multidisciplinary team included Marc Eberhard, University of Washington (team leader); Steve Baldrige, Baldrige & Associates Structural Engineering, Inc.; Justin Marshall, Auburn University; Walter Mooney, USGS; and Glenn Rix, Georgia Institute of Technology.*

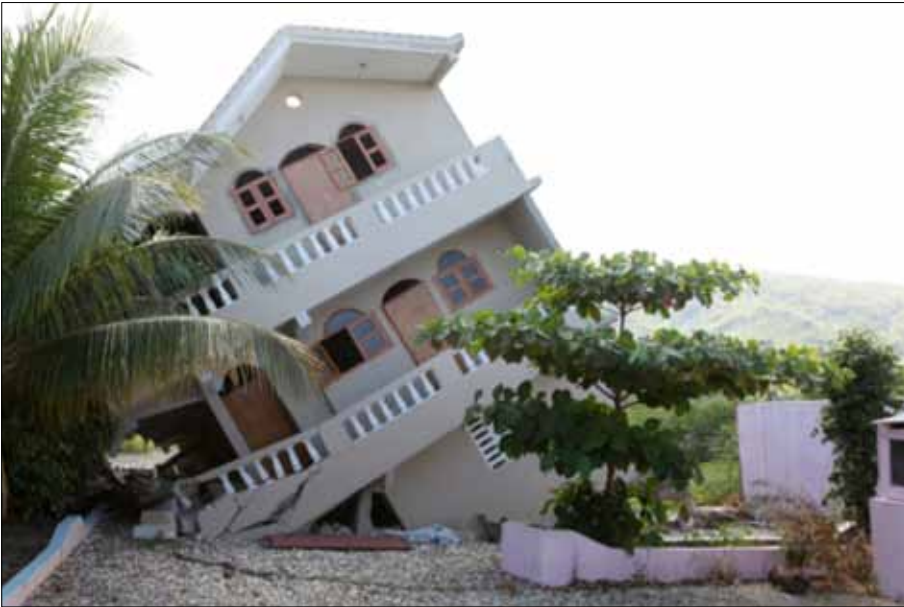
Other less severe liquefaction-related features were observed in the alluvial plain surrounding the city of Léogâne. Figure 3 shows the failure of a structure located about 75 m (246 ft) from the shoreline at 18.446323° N, 72.686259° W. There were several sand boils nearby, the largest of which measured approximately 4 m (13 ft) in diameter. Based on discussions with others who observed this structure (Rathje and Green, 2010), it is likely that a combination of structural and foundation failures contributed to the collapse.

**Figure 3.** Combined structural and foundation failure southwest of Léogâne.

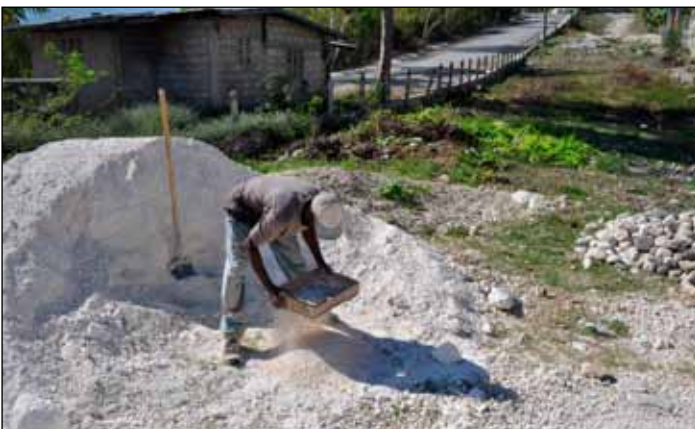
It appears that the widespread damage to residences and commercial and government buildings was largely attributable to the lack of attention to seismic risk in design and construction. In a country as poor as Haiti, typical residences and commercial buildings are constructed informally, with whatever materials and procedures can be afforded. Such structures have not usually been designed formally. For most larger commercial and government buildings that were more likely to have been designed by an engineer, the structural types, member dimensions, and detailing practices were inadequate to resist strong ground motions. These vulnerabilities may have been exacerbated by poor construction practices and difficulties in the procurement of consistent quality construction materials (Figures 4 and 5).

**Figure 4.** Hand sieving aggregate on site for mortar.

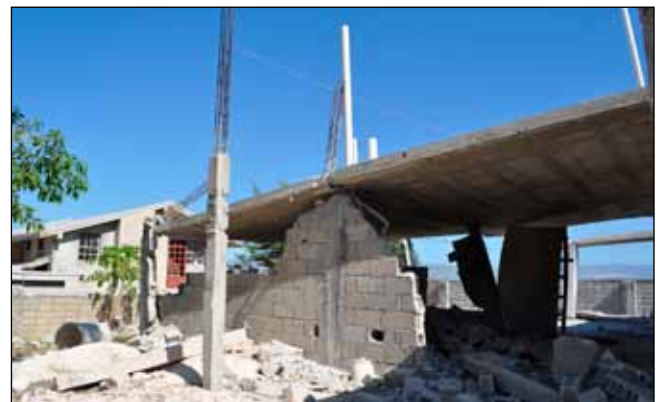
**Figure 5.** Partial collapse of residential building under construction.

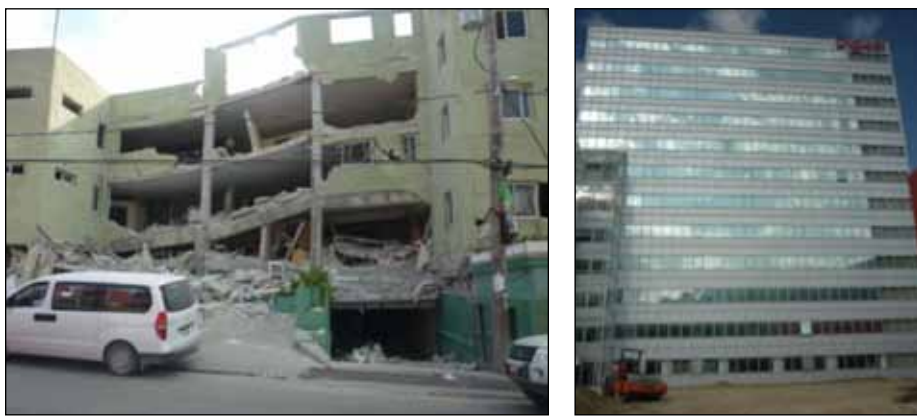
**Figure 6.** Differential damage to two structures across the street from one another in Port-au-Prince: (a) reinforced concrete frame with masonry infill; (b) new Digicel building under construction

Figure 6a shows the collapsed Turgeau Hospital, its lateral-force resistance provided by a reinforced

concrete frame with masonry infill. As with numerous other structures observed by the team, the columns and joints had little transverse reinforcement. The new Digicel building across the street (18.532729° N, 72.323235° W) appeared to be nearly undamaged, with slight damage to a few windows (Figure 6b). The fundamental period of the Digicel building was likely much larger than that of the hospital, so the seismic demands would have differed; nonetheless, the stark difference in performance suggests that the severe damage to numerous buildings could have been avoided with greater attention to seismic performance.

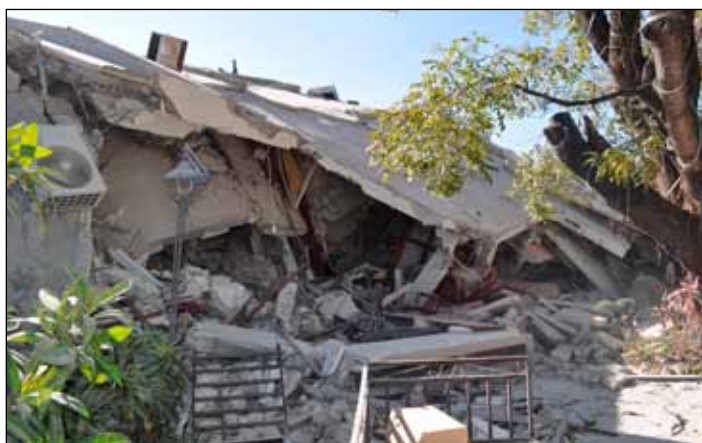
a selection of damaged buildings appeared to have had low deformation demands, it is reasonable to conclude that structures designed and constructed with adequate stiffness and reinforcing details would have resisted the earthquake without severe damage (see Figures 7 and 8).

**Figure 7.** Collapse was extensive throughout the guest wings of the Hotel Montana, constructed of reinforced concrete with unreinforced infill concrete masonry walls.

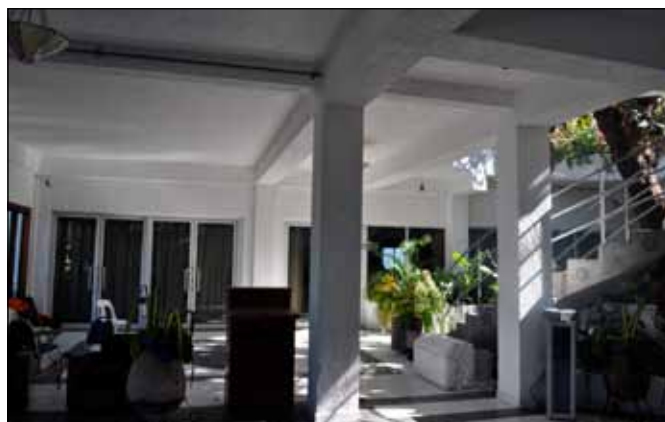
**Figure 8.** Areas of the Hotel Montana lobby remained intact. It appeared that this part of the building had reinforced concrete beams and slabs without extensive infill walls.

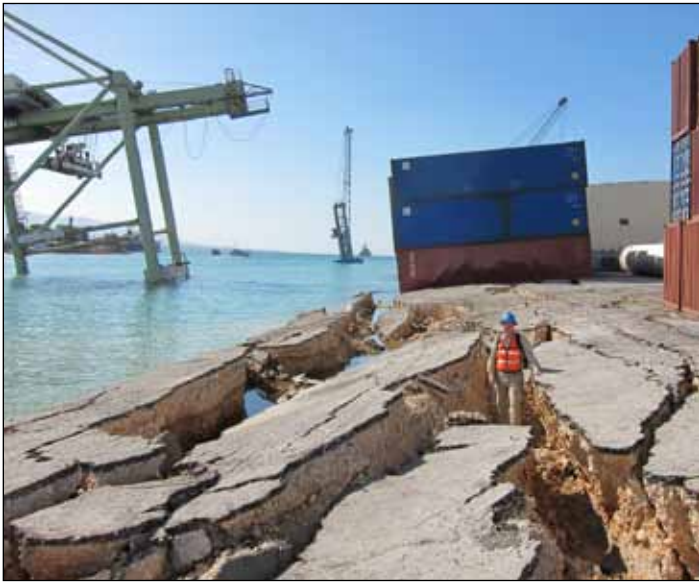
The main port in Port-au-Prince suffered extensive damage during the earthquake, inhibiting the delivery of relief supplies. The collapse of the North Wharf appears to have been caused by liquefaction-induced lateral spreading (Figure 9). There were three cranes at the North Wharf, including one 15-m (50-ft) gauge, A-frame container crane, and two rubber-tired mobile

**Figure 9.** Fissures caused by lateral spreading at western ends of the North Wharf.

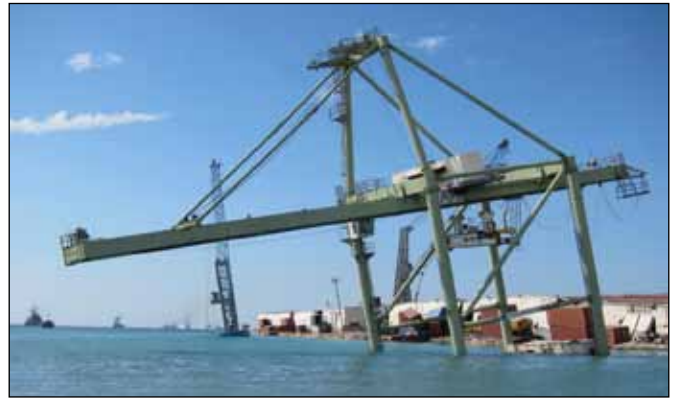
cranes. Apparently, two of the three cranes were on the North Wharf at the time of the earthquake and are now partially submerged. Figure 10 shows the A-frame container crane in the foreground and a submerged mobile crane in the background.

**Figure 10.** Submerged 15-m gauge container crane (foreground) and mobile crane (background)

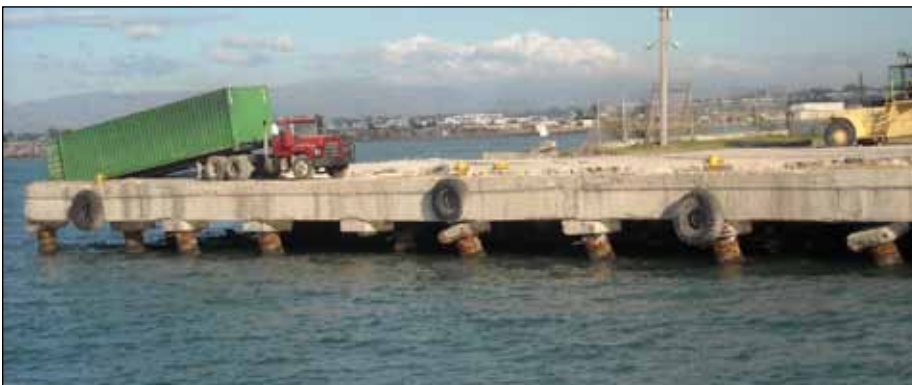
The westernmost 120 m (400 ft) of the South Pier collapsed, and approximately 85% of the vertical and batter piles supporting the remaining section were moderately damaged or broken. The remaining section of pier was shut down to vehicle traffic following additional damage during an aftershock. The collapse of a pile-supported pier at the Varreux Terminal resulted

in the deaths of about 30 people working on the pier at the time of the earth-

**Figure 11.** Remaining portion of pile-supported pier at the Varreux Terminal (source: Chodkiewicz).

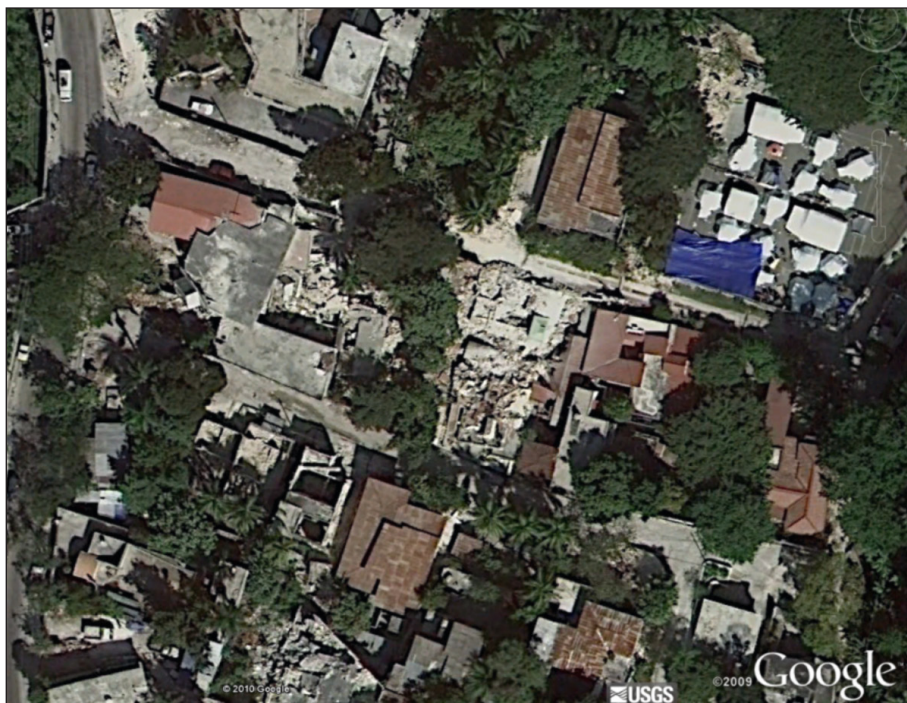
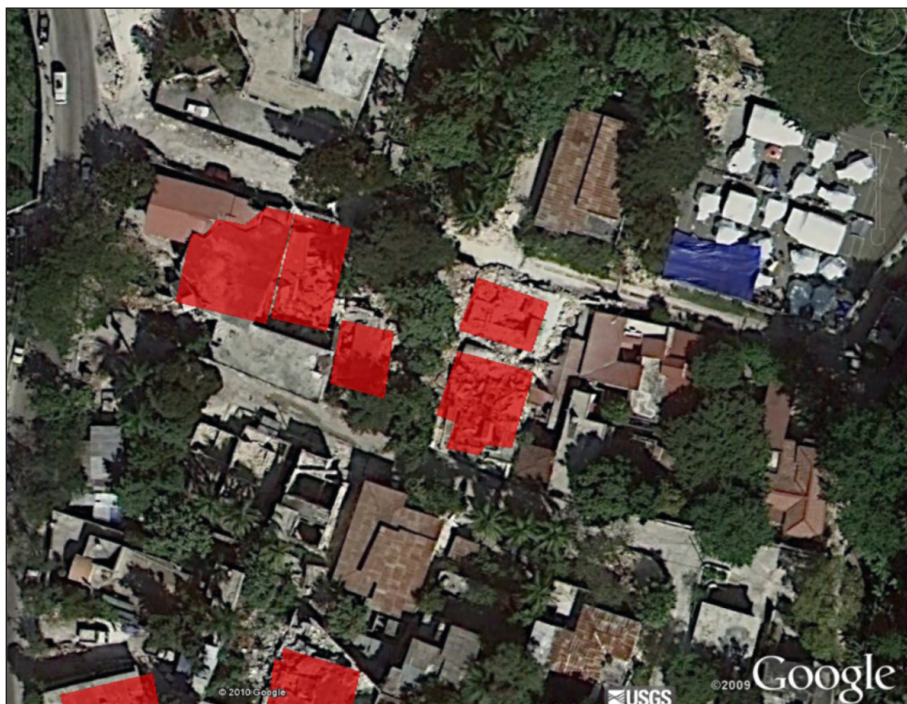
**Figure 12.** ▲ Image above shows damage; ▼ image below indicates buildings that have been marked as partial or complete collapse in the web-based analysis.

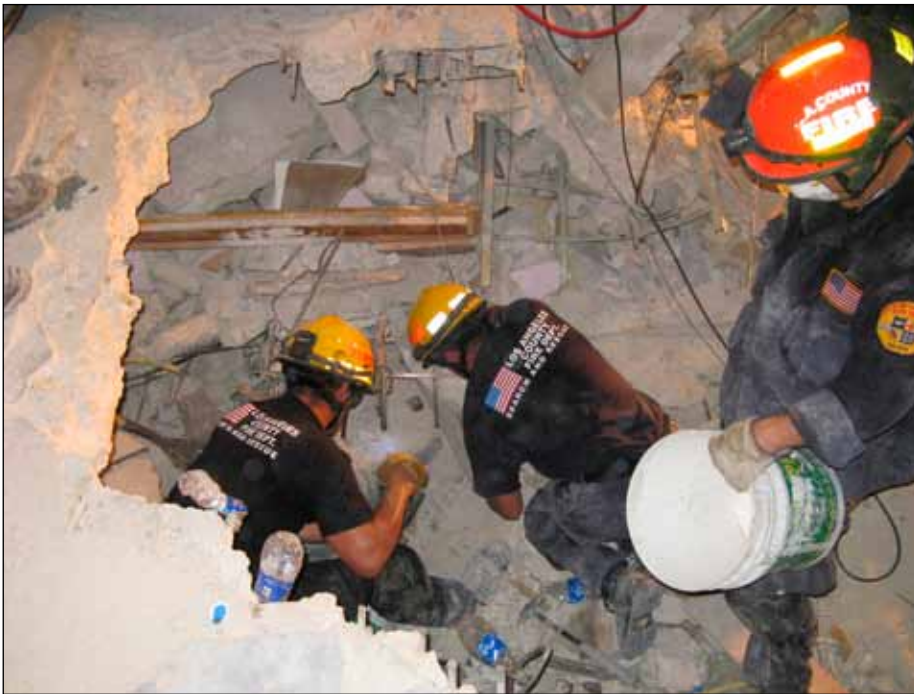
**Figure 13.** Three-person rescue in Port-au-Prince store (photo: Gartner).

Most of the collapsed buildings observed were constructed of concrete/concrete masonry one-way slabs with flush beams supported on concrete columns having minimal reinforcement. Floor slabs had a mix of smooth and deformed reinforcement (see Figure 13). Distribution and size of steel reinforcement in the floor system was typically minimal, with certain buildings having greater amounts of reinforcement based on use. Unreinforced hollow cell concrete masonry had been used to construct internal partitions and exterior walls; frequently the cells were not grouted. The concrete and masonry appeared to be

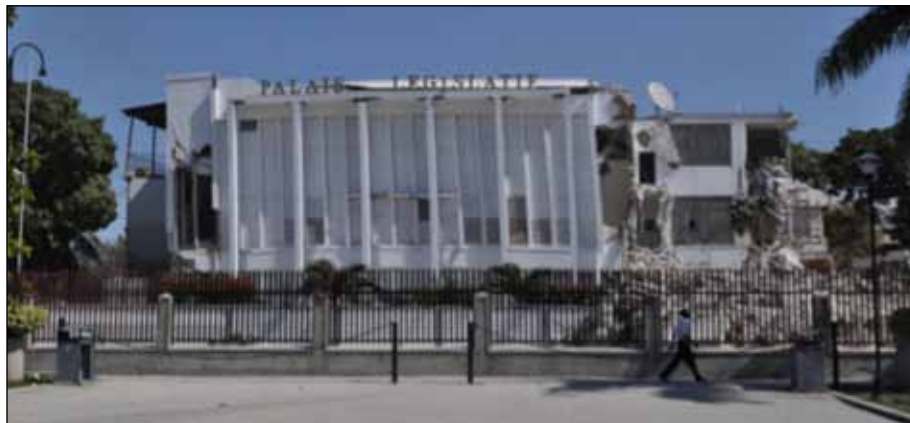
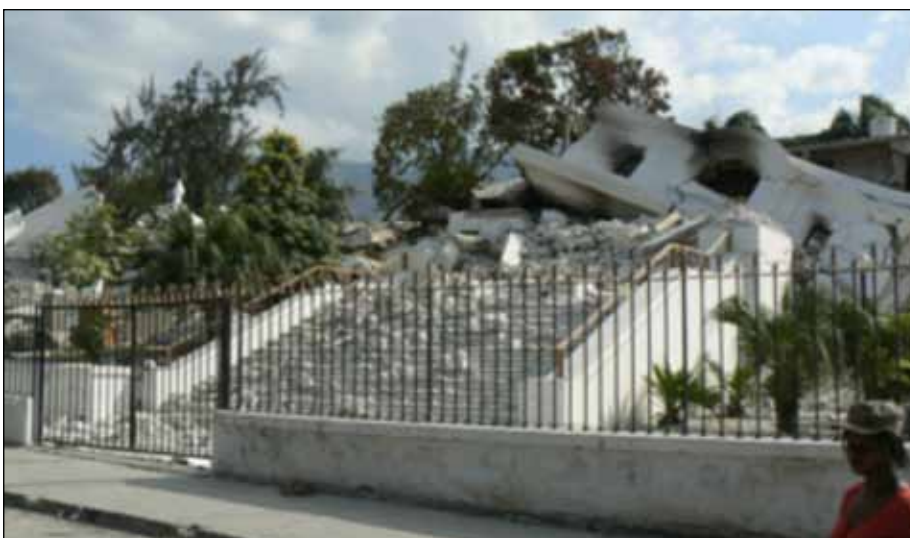
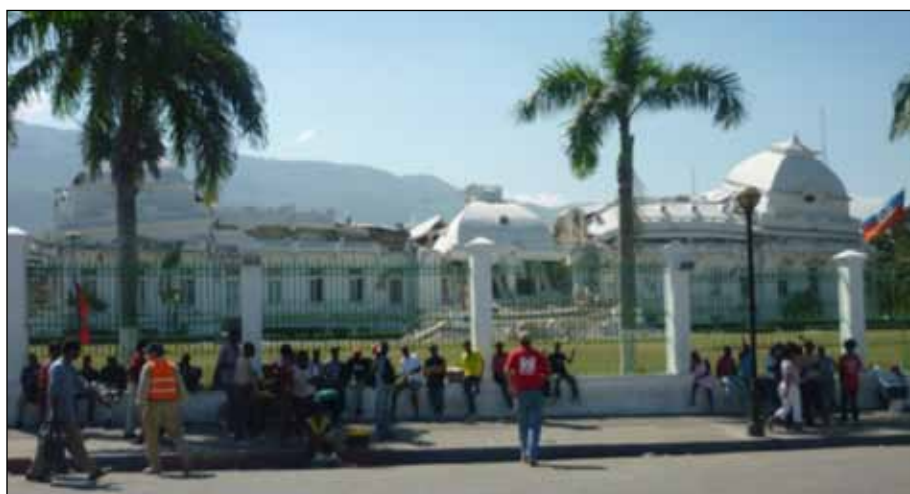
The functioning of the government and other institutions was seriously handicapped by the loss of personnel, records, and facilities (Figure 15). Numerous clinics, hospitals, police stations, ministries, schools, universities, palaces, and churches were triply disadvantaged. The absence of social infrastructure has compromised the recovery and reconstruction efforts.

**Figure 15.** Top: Legislative Palace; middle: Judicial Palace; bottom: National Palace.
