Learning from Earthquakes

The Pisco, Peru, Earthquake of August 15, 2007

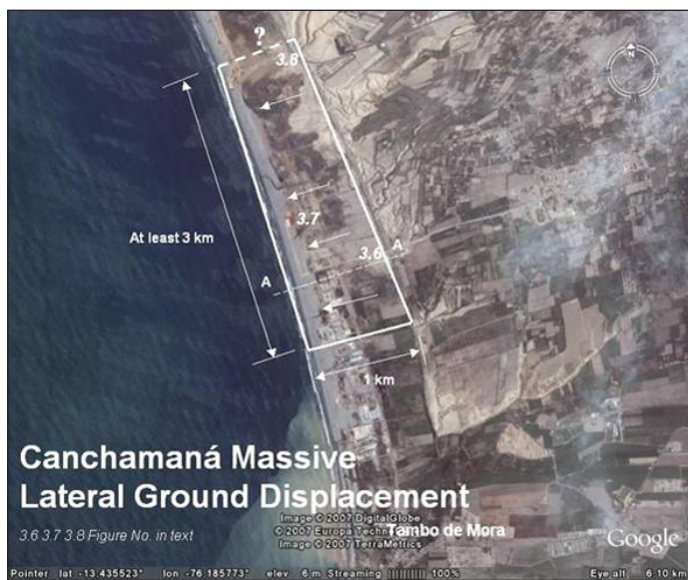
Figure 4. Approximate area of seaward lateral displacement of a marine terrace in Canchamana (background image from Google Earth).

The earthquake spawned a wide variety of liquefaction failures. Notable liquefaction-induced damage included a massive lateral spread extending over approximately 3 km (Figure 4), a 400 m-long slope failure induced by liquefaction at the toe, spectacular one- to two-story building foundation failures resulting in up to 0.90 m of settlement (Figure 5), numerous highway

The massive liquefaction-induced seaward displacement of a marine terrace in Canchamaná, 2.5 km north of Tambo de Mora, was 1 km wide by 3 km long (Figure 4). The eastern boundary of the lateral spread was defined by the interface between a Holocene marine terrace and the Pleistocene Cañete formation. The southern boundary appeared to be defined by the interface of the marine terrace with a Holocene alluvial sand deposit. The northern boundary was

not firmly established, but appeared to be influenced by the presence of human-made works at a bend in the Pan American highway. The westward slope of the marine terrace surface was approximately 1.6 to 2.1 %. A clear vertical offset (scarp) of variable magnitude was observed along much of the geological interface between the marine terrace and the Cañete formation (Figure 6). In addition to the main scarp at the interface, numerous extensional ground cracks developed across the marine terrace parallel to the coastline. In general, the cracks were largest (both in terms of horizontal and vertical displacement) near the scarp and became smaller towards the coastline. Some crack widths were as large as 1 m and sand ejecta was found inside many of them.

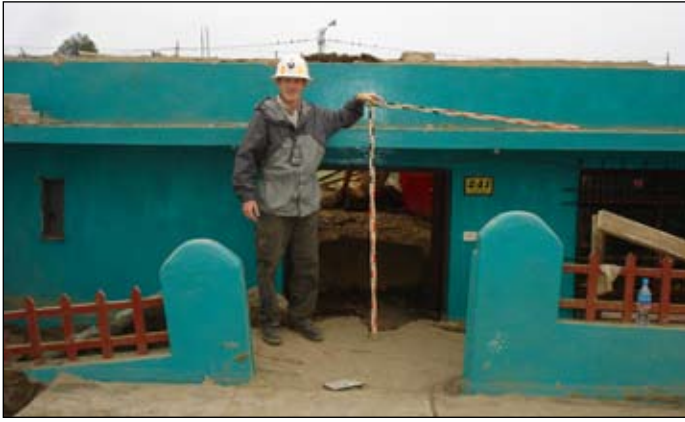
Figure 5. Approximately 0.9 m of liquefaction-induced settlement at a one-story residence in Tambo de Mora.

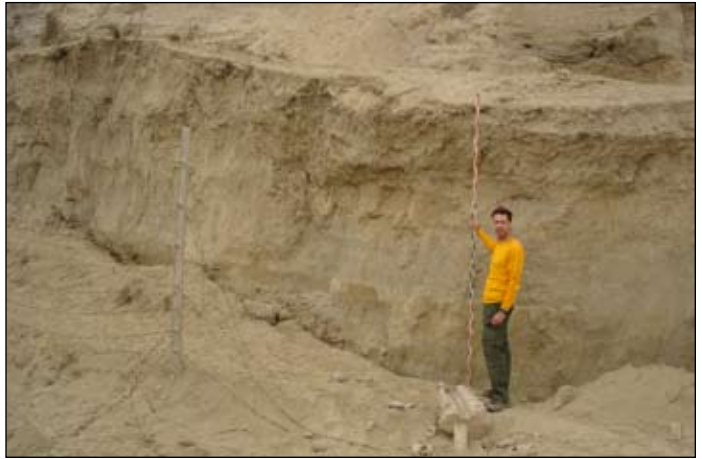
Figure 6. Maximum vertical offset of approximately 3.0 m along the interface between the marine terrace deposit and the Cañete formation in the Canchamana lateral slide.

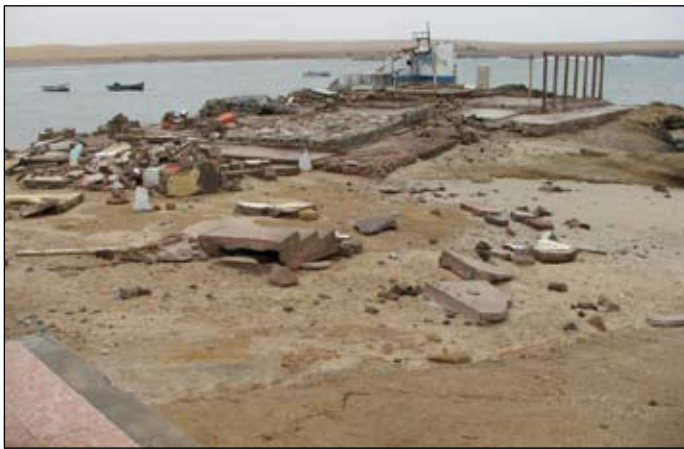
Figure 7. Debris on the shore at the fishing village of Lagunilla, which was completely destroyed by the tsunami.

the tsunami peaked in a mostly uninhabited desert area. At Lagunilla, the tsunami flooded up to 2 km inland over extremely flat terrain, with 4 m runup at the inundation limit and 5-6 m runup at the village on the shoreline (Figure 7). Similar runup heights and flow depths during the 2004 Indian Ocean tsunami resulted in much higher death tolls in Sri Lanka (Liu et al., 2005) and Somalia (Fritz and Borrero, 2006).

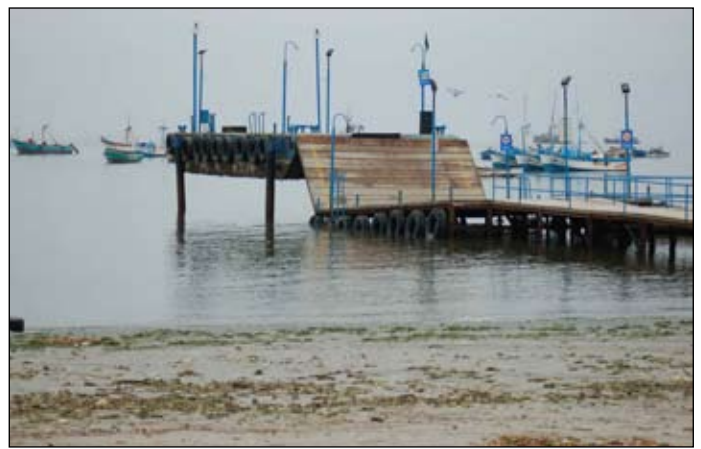
Figure 8. Paracas marina tsunami height measured based on a floating dock stuck in an uplifted position.

In Paracas, there was damage to the dock, a fixed platform supported by piles embedded in sand with a floating platform at the end. The sand supporting the dock liquefied and the piles lost bearing capacity and sank differentially into the sand up to approximately 30 cm, while the floating dock rose with the tsunami and became stuck when the water level went down (Figure 8).

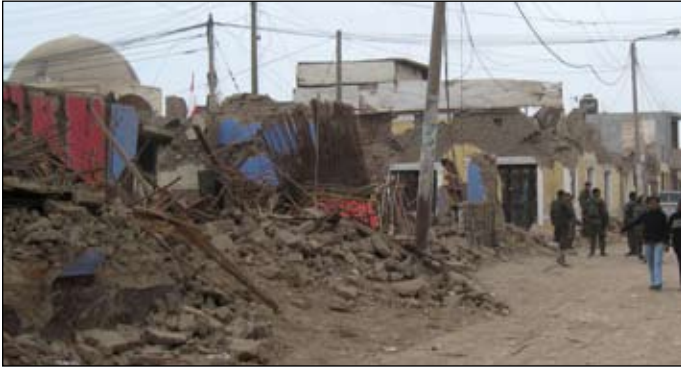
Figure 9. Street in Pisco three days after the earthquake. The house at the far right, undamaged, was made of confined masonry.

In Pisco, closest to the epicenter, more than 80% of the adobe houses collapsed or sustained heavy damage (Figure 9). Apparently, the adobe blocks and mortar in the Pisco and surrounding areas were made with sandy soil, which did not have sufficient clay to provide good adhesion between mortar and adobe blocks.

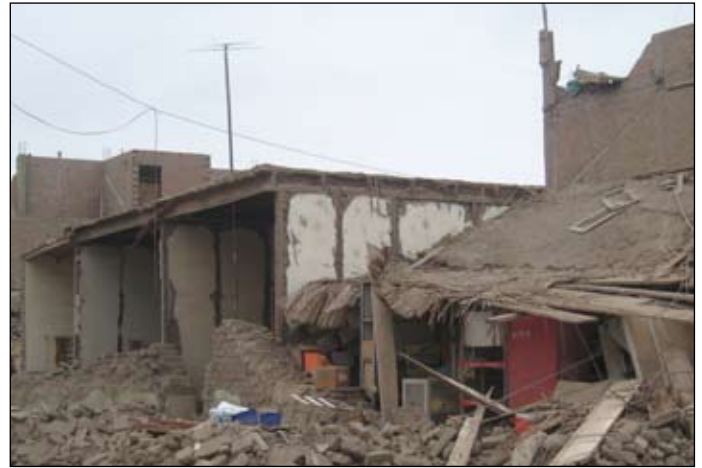
The most common type of failure observed in adobe houses was due to the formation of vertical cracks at the corners of the façade walls as a result of out-of-plane shaking, followed by the collapse of the walls onto the street, and sometimes the collapse of the roof (especially if the roof joists were supported on the façade wall). A top collar beam joining all

Figure 10. Two collapsed adobe houses in Pisco. The roof joists of the house on the left are supported on the quincha partitions. The roof joists of the house on the right were supported on the façade wall, and thus collapsed with the façade. Notice the undamaged confined masonry house at far left.

walls probably would have been helpful to prevent this type of damage (Figure 10).

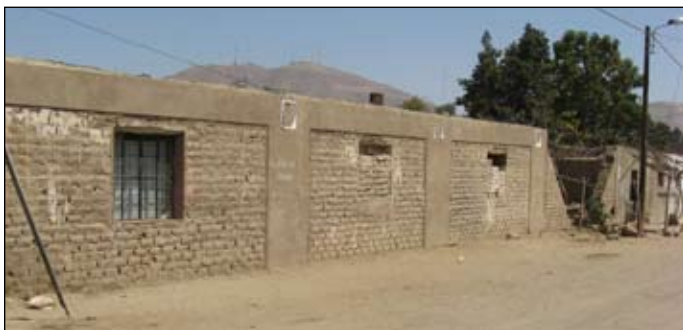
Reinforced adobe: In 1999 the Catholic University of Peru (PUCP) reinforced 19 adobe houses in different locations of the country. The reinforcement consisted of bands of welded wire mesh nailed to the walls and covered with a cement-sand mortar. Figure 11 shows the house that was built in Guadalupe, a small town near Ica. It did not suffer any damage during the earthquake, whereas neighboring unreinforced houses were damaged or collapsed. This reinforcing system

Figure 11. This undamaged adobe house was reinforced with bands of wire mesh covered with sand-cement mortar. Vertical bands were placed at each wall intersection, and horizontal bands at roof level. Notice the collapsed unreinforced wall at the right.

should be used with caution because, although shaking table tests have shown that the strength of the adobe walls is significantly increased, the mode of failure is brittle.

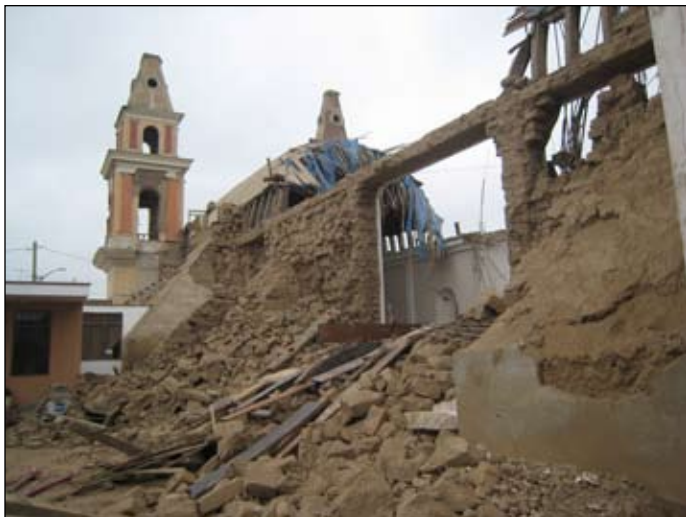
Figure 12. San Luis Church. The lateral wall and its heavy abutments were torn down, presumably by the dynamic thrust of the collapsing vault.

Churches: Many beautiful old churches in Peru are built with adobe walls and a quincha vault covering the nave. Most churches were damaged during the earthquake. The most dramatic case was that of the San Clemente church in Pisco, where the vault collapsed suddenly and killed around 160 people who were attending a funeral service. The priest was saved because he was under the dome, which had been repaired with reinforced concrete after a previous earthquake. Figure 12 shows a side view of the church of San Luis, in a small town just south of Cañete.

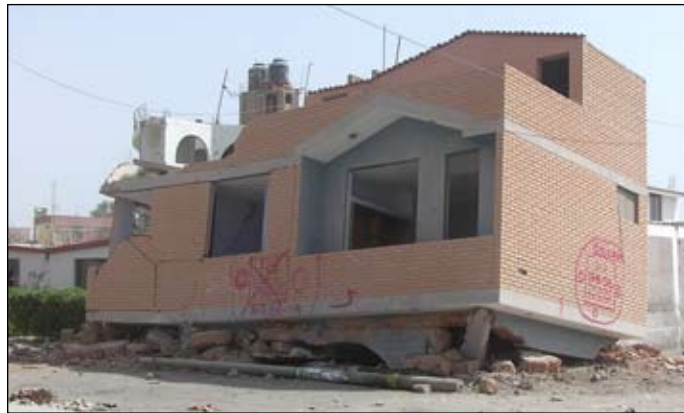
Confined masonry with soft stories, relevant irregularities, or bad detailing, collapsed or showed severe damage (Figure 13). Modern and well-designed confined masonry resisted the earthquake with little or no damage, including the confined masonry made with hollow clay tile that was thought to perform poorly.

Figure 13. Confined masonry with soft stories, relevant irregularities, or bad detailing, collapsed or showed severe damage.

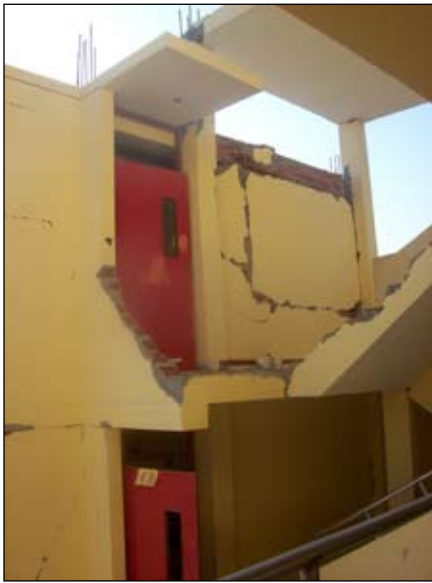
Figure 14. Extensive masonry wall damage.

separate the structures at all levels. It appears that no seismic joint was used to separate the main classroom building and the adjacent two-story east wing. Pounding damage was observed throughout the height of the buildings with significantly more damage on the top floors. Although compressible foam was used in the seismic joint, grouting was found to infill the top. The main lateral system of all the buildings suffered insignificant damage, but the unreinforced masonry walls suffered significant damage during the earthquake (Figure 14). Most of these walls need to be demolished and replaced. Several partial brick infill walls next to the corridor completely collapsed.

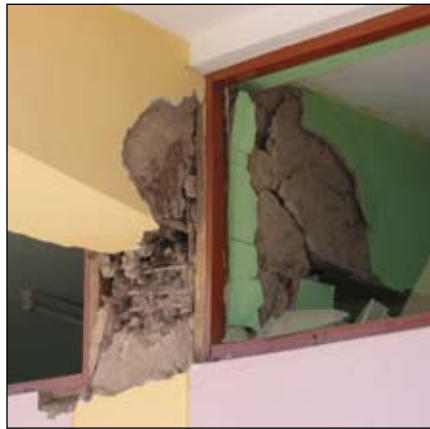
Figure 15. Shear failure of short columns next to corridor.

and back, respectively. This resulted in severe shear failure of the columns in the front, which were on the verge of losing gravity-carrying capabilities (Figure 15). The windows next to the short columns fractured and fell on the floor. The front masonry infill in the first-story also experienced the moderate diagonal cracking. The partial brick infill created the short column condition, and caused the center columns at the second story to experience shear cracking. The water table at the site is approximately four feet below the ground surface and signs of sand boiling were observed in several locations behind the building complex.

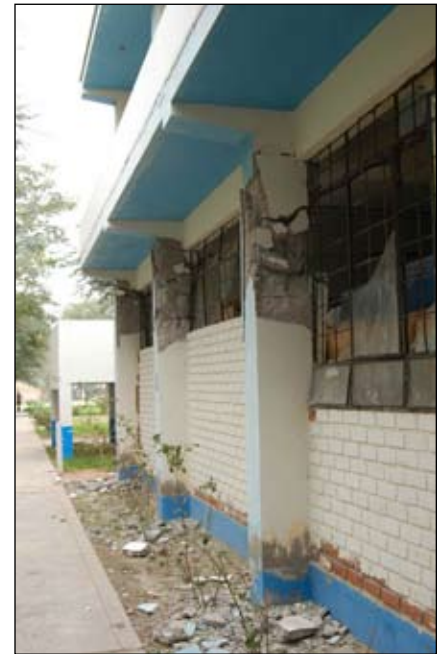
The University San Luis Gonzaga in Ica: Many buildings were damaged here due to the presence of short columns (Figure 16). Some of the building had the infill panels isolated from the frames. These panels were supported by a frame for the out of plane forces. The connection of this frame to the main frame was inadequate. With the bars anchored only 4-5 inches into the main frame, the out-of-plane forces made these frame collapse or nearly so.

Figure 16. Damaged building at the University San Luis Gonzaga due to short columns.

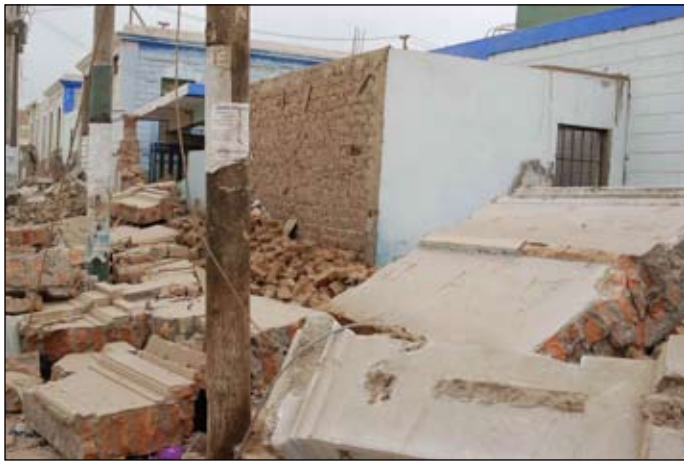
Figure 17. Damage to Pisco Hospital.

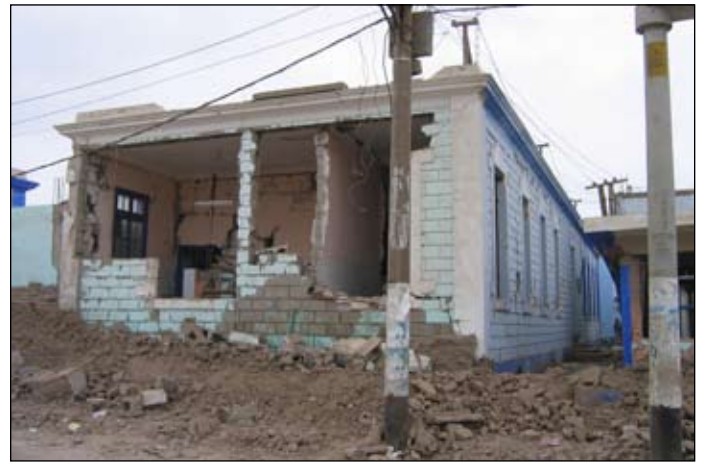
Figure 18. Damage to a Pisco Hospital building with window openings at one end and a door opening at the other.

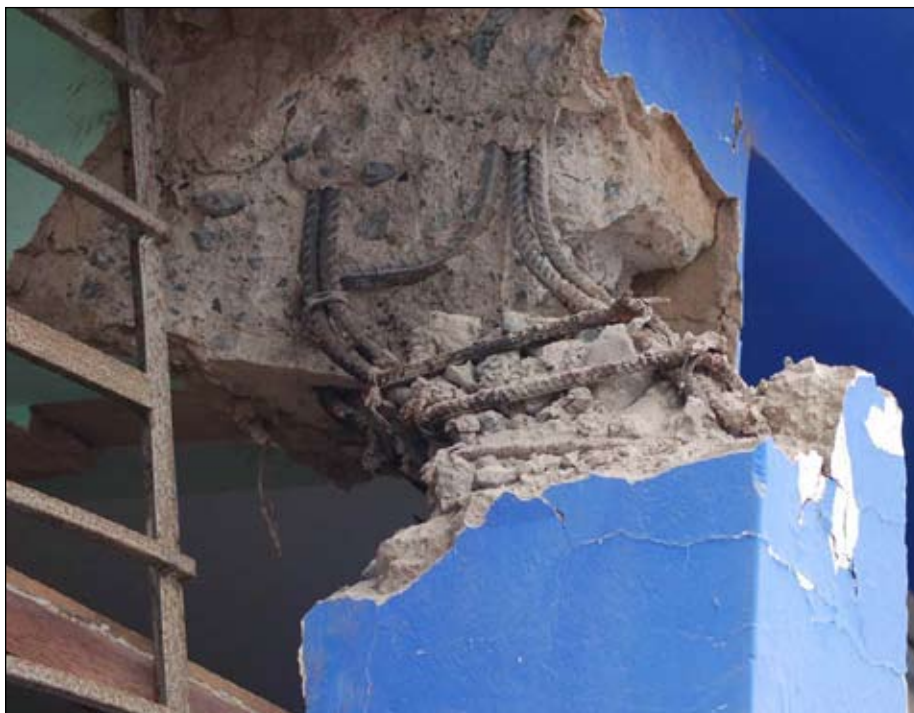
The only original construction that did not experience some structural damage was the kitchen/mechanical equipment building. This is due to its lateral force system of multiple lines of concrete shear walls in each direction. After the earthquake, the hospital salvaged medical beds and medical equipment and supplies and moved them into the newly constructed buildings. Figure 18 shows the structural damage to an original building with window openings at one end and a door opening at the other. Significant torsional response of this building caused the wall piers adjacent to the windows to suffer more damage, resulting in the out-of-place collapse of the windows and the walls. Figure 19 shows damage to a reinforced concrete building.

Figure 19. Damage to a reinforced concrete building at Pisco Hospital.

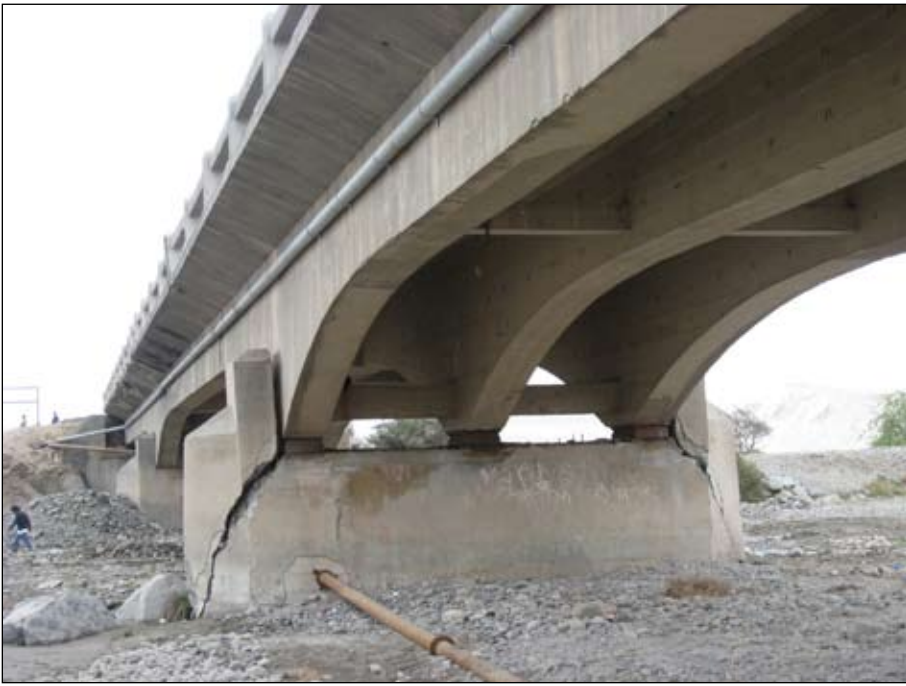
Figure 20. Evidence of liquefaction was observed at three piers of the Huamani Bridge along the Pan American Highway and in the surrounding area.

In general, most of the bridge structures in the epicentral region performed well. Damage was observed only at the site where liquefaction was also observed. The Huamani Bridge along the Pan American Highway near the town of San Clemente used pier walls with relatively low height to width ratios, and superstructures with several expansion joints. Evidence of liquefaction was observed at three piers and in the area surrounding these piers (Figure 20). The bridge had a total of five spans with lengths ranging from approximately 70 feet to 90 feet. The spans between piers 1

and 2, and between piers 3 and 4 had segments of superstructure supported on expansion joints at both sides. Permanent displacements on the order of 4 inches in the transverse direction were observed at the expansion joints of both of these segments.

Other damage to the superstructure consisted of wide shear and flexural cracks in the diaphragm beams of piers 1 and 2. Due to the type of support used, the transverse motion of the bridge girders induced significant demands on the diaphragm beams. When the reconnaissance team first arrived it was open in one direction, but was closed several days later.

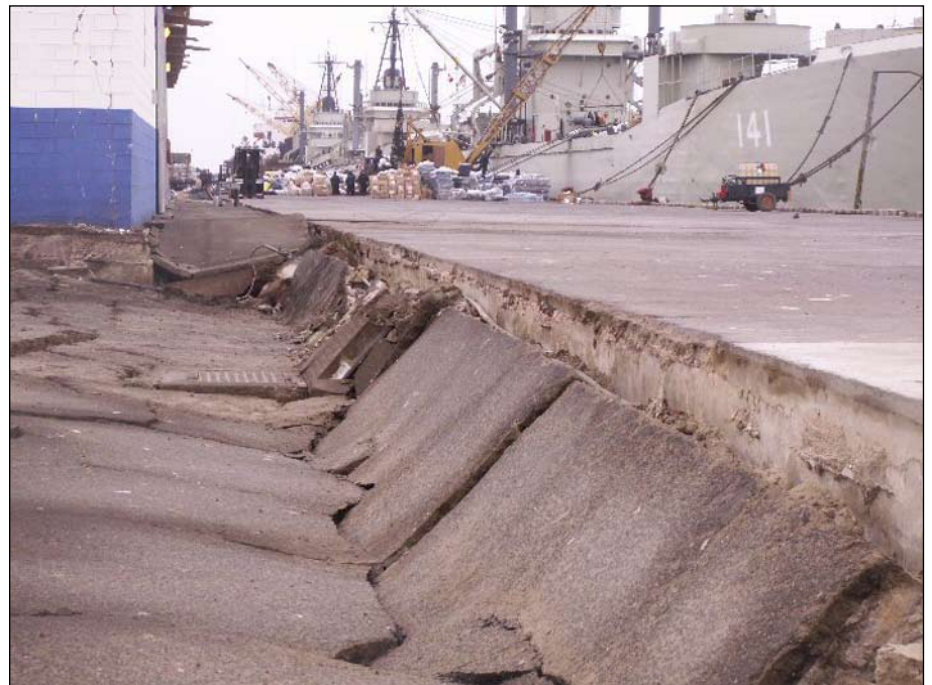
Ports: Small piers were slightly to moderately damaged in Pisco and Paracas. The most significant damage was at the Port of San Martín. It has a wharf about 1000 m long (Figure 21). The front (water side)

Figure 21. The fill behind a sea wall settled about 1 m at the Terminal Marítimo General San Martín.

20 m is pile-supported. The fill behind a sea wall settled about 1 m and pushed the wall towards the piles, slightly bending them. A warehouse just behind sea wall has pile-supported walls. The floor and surrounding area settled about 60 cm, with extensive evidence of liquefaction.
