Learning from Earthquakes

The M 6.3 Christchurch, New Zealand, Earthquake of February 22, 2011

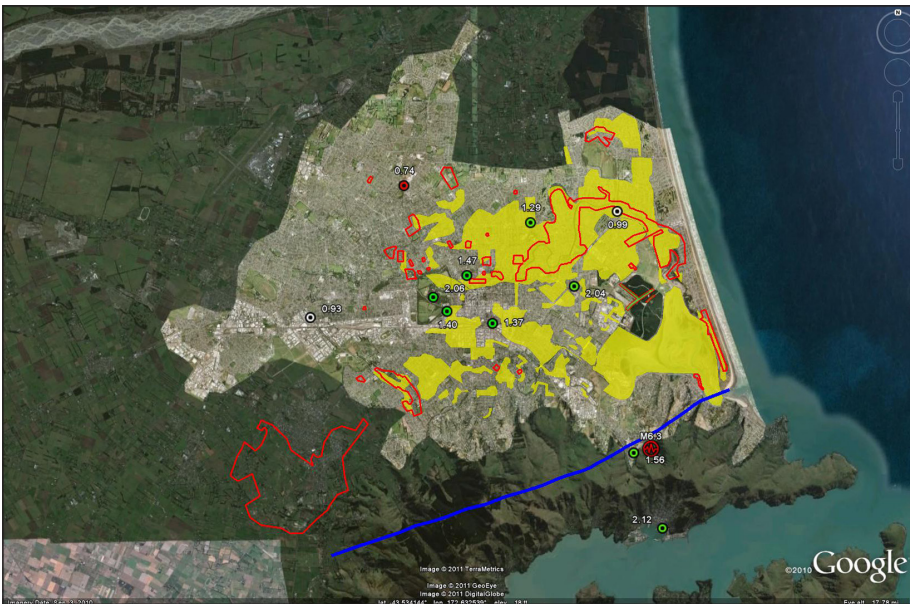
Figure 3. Liquefaction in February 2011 (green) and September 2010 (red contours) (courtesy of R. Green; GEER 2011).

Liquefaction. Liquefaction was widespread in the CBD and surrounding suburbs (Cubrinovski and Taylor 2011), and covered a greater area than had been indicated on the Environment Canterbury liquefaction hazards maps produced by Environment Canterbury in 2004. A range of liquefaction-induced phenomena were observed, including sand boils, settlement, uplift, and lateral spreading. The region affected was considerably larger than that of the September 2010 earthquake (Figure 3), with more than 50% of the Christchurch area affected. As much as 2-3m of lateral spread and 1-2m of settlement were observed in the eastern suburbs. The combined settlement caused by liquefaction during the recent earthquakes and aftershocks has exposed many Christchurch neighborhoods to increased threats from river and ocean flooding, including tsunamis.

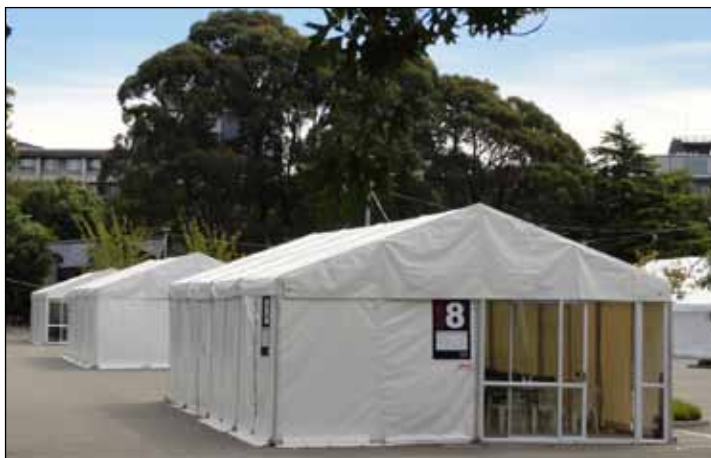
Figure 19. Classroom tents in the car park of the University of Canterbury, March 14, 2011 (photo: Comerio).

The University of Canterbury (UC) progressively reopened within 3-4 weeks of the earthquake while promising to deliver a high-quality, full academic year program of teaching and offering grants to compensate students. Across all educational institutions, alternative classroom capacity was created with temporary classrooms (Figure 19), off-site venues, site sharing, correspondence

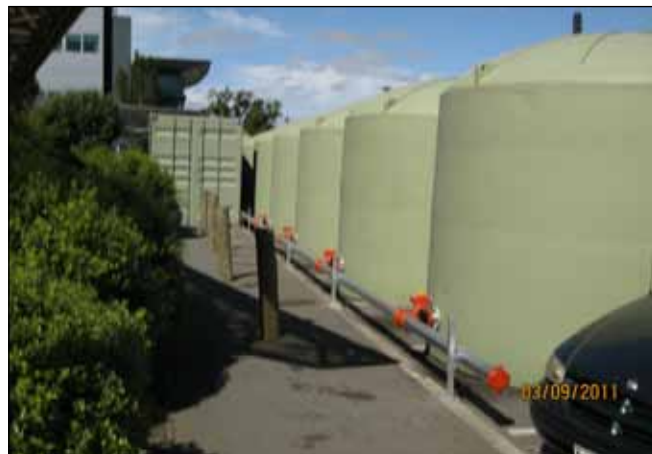
Figure 20. Temporary water tanks in front of Christchurch Hospital (photo: Gavin).

Hospital. The Christchurch Hospital—the South Island's largest tertiary hospital with 600-650 beds—suffered little structural damage, but had to evacuate 160 patients and request support from other facilities to cover functions such as laundry service. The hospital's backup power generators failed due to sludge clogging the filters, forcing patients to be evacuated from the main ward. The hospital also had to move patients from the fourth and fifth levels of the Riverside building due to leaks caused by sprinkler damage. Pipe failures were also discovered in the sewage system. Ceiling damage was prevalent in older buildings with heavy plaster tiles, while lightweight ceilings performed well. The hospital was also suffering from a lack of water pressure due to liquefaction damage to the tunnel housing pipes that carry steam from the boilers across the street to the hospital; as a precaution, the hospital has brought in storage tanks with almost 53,000 gallons of water (Figure 20). There were several instances of mechanical equipment jumping off mounts, as well as overturned furniture. One building on the hospital's campus, the Hagley Nurses Hostel,

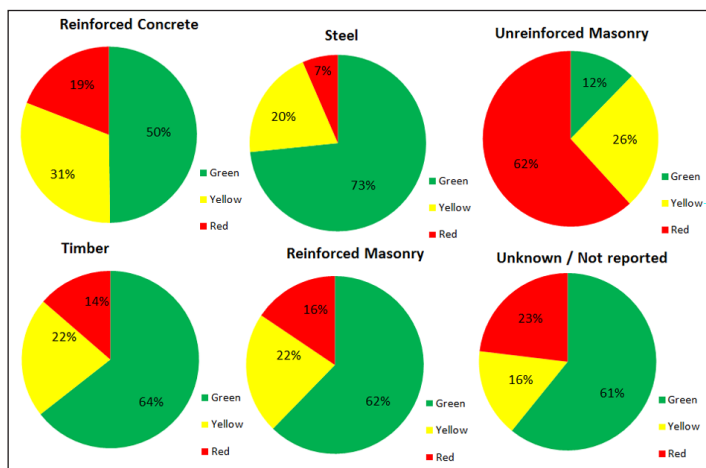
As of April 15, more than 60,000 total assessments have been accomplished, with the following breakdown of red tagged buildings: 1788 residential buildings, 1109 buildings within the CBD, including 395 heritage buildings (Civil Defence 2011). Figure 22 shows the

Figure 22. Building Assessments in Central Business District (Kam et al. 2011, Data source: Christchurch City Council)
