## Learning from Earthquakes

# The $M_w$ 7.0 Haiti Earthquake of January 12, 2010: Report #1

*This is the first of multiple Newsletter inserts on the Haiti earthquake of January 12, 2010. It summarizes observations from the advance team organized by the U.S. Geological Survey (USGS) and EERI that traveled to Haiti January 26 to February 3, 2010. The multidisciplinary team included Marc Eberhard, University of Washington (team leader); Steve Baldrige, Baldrige & Associates Structural Engineering, Inc.; Justin Marshall, Auburn University; Walter Mooney, USGS; and Glenn Rix, Georgia Institute of Technology.*

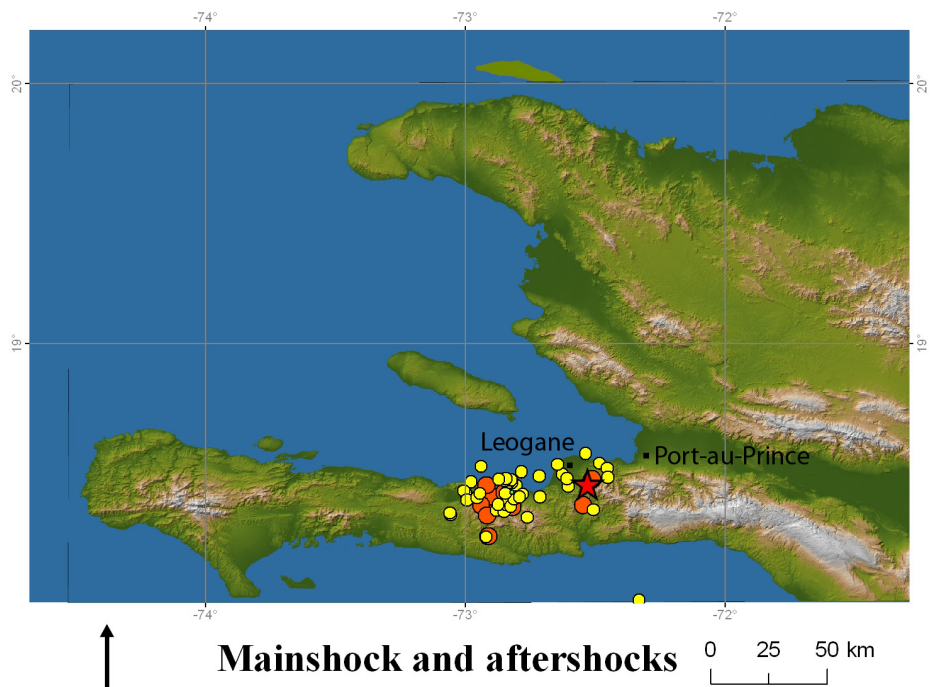
**Figure 1.** Topographic map of Haiti with the January 12, 2010, main shock ( $M7$  star) and aftershocks ( $M5-6$  orange and  $M4-5$  yellow) in the first two weeks. Many aftershocks struck 40-50 km west of the main shock, at the west end of the subsurface fault rupture (USGS, 2010).

The January 12 quake struck at 04:53 PM local time. The USGS epicenter was 18.457° N, 72.533° W, 25 km WSW of Port-au-Prince on or near the Enriquillo fault (Figure 1). The estimated depth was 13 km, but the lack of local seismic data makes the precise depth uncertain. The USGS assigned a horizontal uncertainty of +/- 3.4 km. The focal mechanism for the main shock indicates left-lateral oblique-slip motion on an east-west oriented fault. The fault ruptured from east to west, away from Port-au-Prince and towards the cities of Léogâne, Grand Goâve, and Petite Goâve. The USGS finite-fault model shows a maximum slip of 5 m up-dip from the hypocenter (Figure

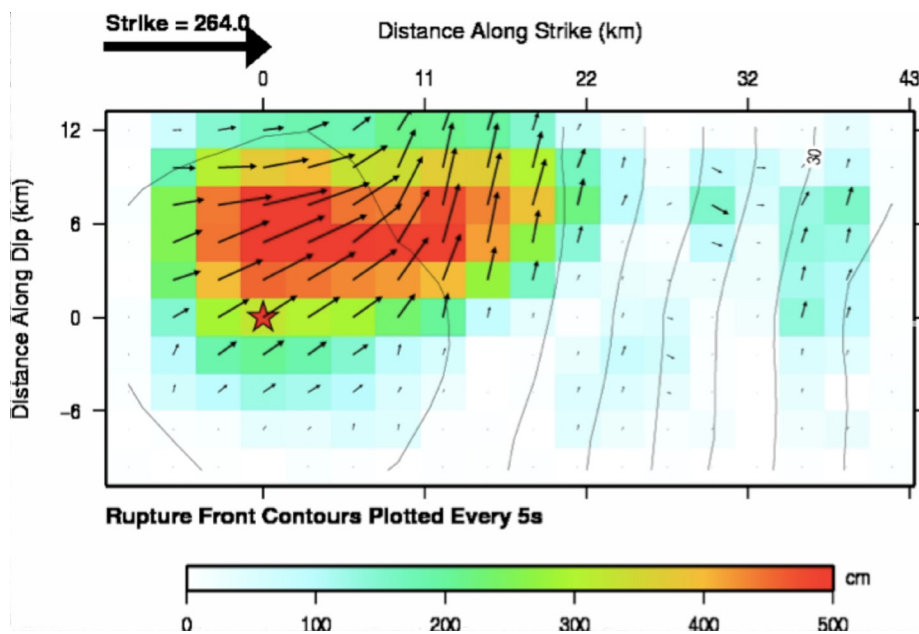
2). The earthquake source zone (the surface area of the fault that slipped) is quite compact, with a down-dip dimension of approximately 15 km and an along-strike dimension of 30 km. This source dimension is about one-third the size of a typical  $M_w$  7.0 earthquake. The earthquake rupture was very abrupt and sharp; maximum moment release occurred in the first 10 seconds of the fault slip.

**Figure 2.** USGS finite-fault model indicates the amount of slip on the fault plane during the earthquake. West is to the right (Hayes, 2010).

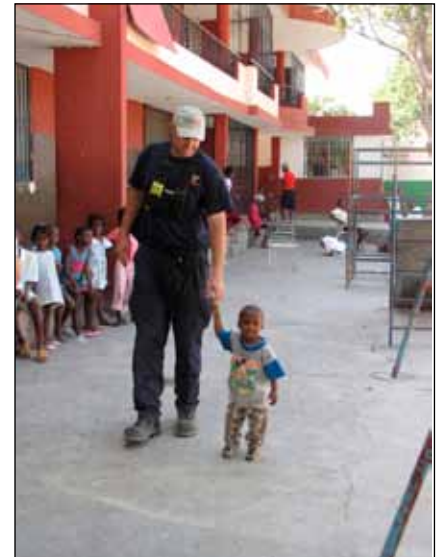
**Figure 14.** Humanitarian aid at an orphanage (photo: Harris).

The secondary mission of the USAR Task Forces was to deliver humanitarian relief to orphanages and hospitals identified by USAID (see Figure 14). Task Force members installed tents and generator power systems, performed structural assessments of buildings, and assisted with medical assessments of orphans.
