Learning from Earthquakes

The Pisco, Peru, Earthquake of August 15, 2007

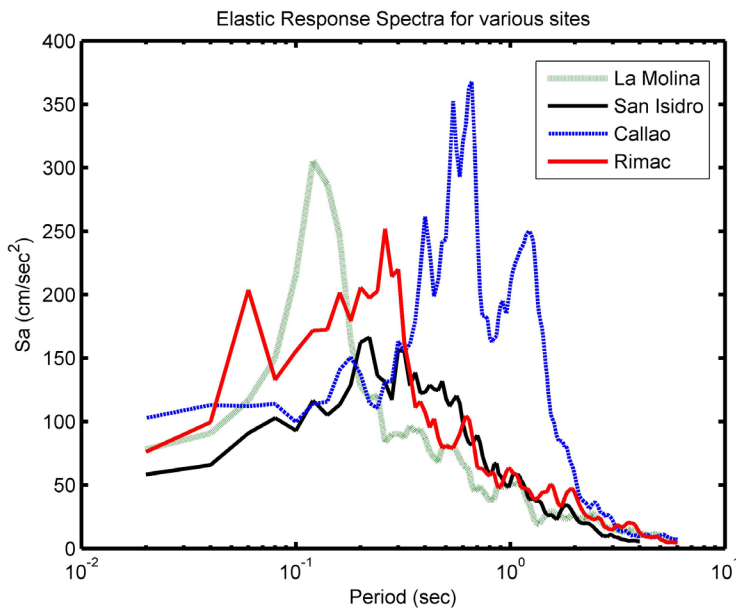
Figure 2. East-west spectral accelerations recorded by CISMID stations (from Lazares et al., 2007). All stations are located at a range of 96-111 km from the fault plane. The Rimac and San Isidro stations are located on dense, stiff gravel deposits (referred to as Lima Conglomerate); the La Molina station is located on shallow soil overlying the denser Lima Conglomerate; the Callao station is located on soft soil.

The earthquake was recorded at 16 stations within 150 km of the fault plane. All of the stations except for two in Ica are located approximately 100 km to the north in the vicinity of Lima. A pattern of higher PGAs at soil stations was observed; additional evidence of site effects is seen by the distinctly different spectral shapes observed in the four CISMID stations (Figure 2), which are located in three different soil types. Site effects are manifested by significant amplification over period bands that are compatible with the general site description (i.e., shallow, stiff soil deposits at La Molina, and soft soils at Callao).

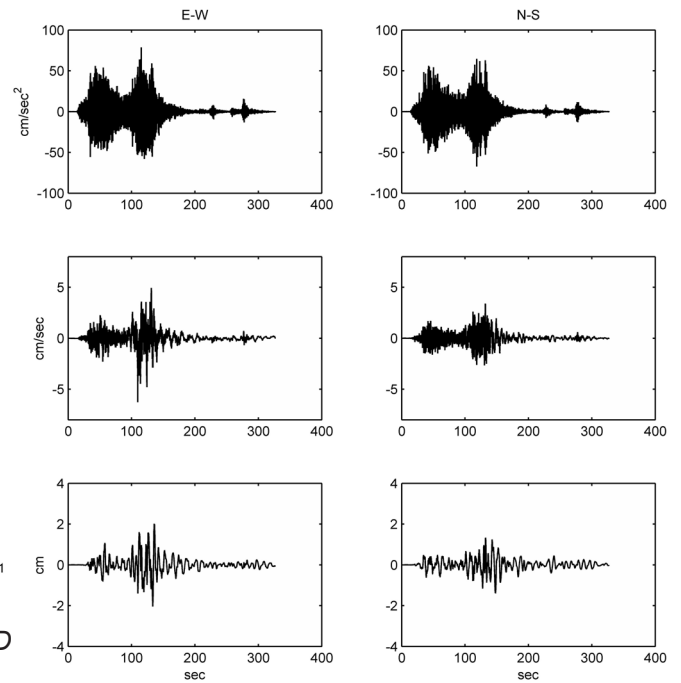
Figure 3. Acceleration, velocity, and displacement time histories for the La Molina record (stiff soil).

Figure 3 shows the ground motion record from La Molina. It shows two phases of strong ground motion, which correspond to slip along two asperities in the finite fault solution of Ji and Zeng. The overall shape of the acceleration time history is similar for other ground motion stations.

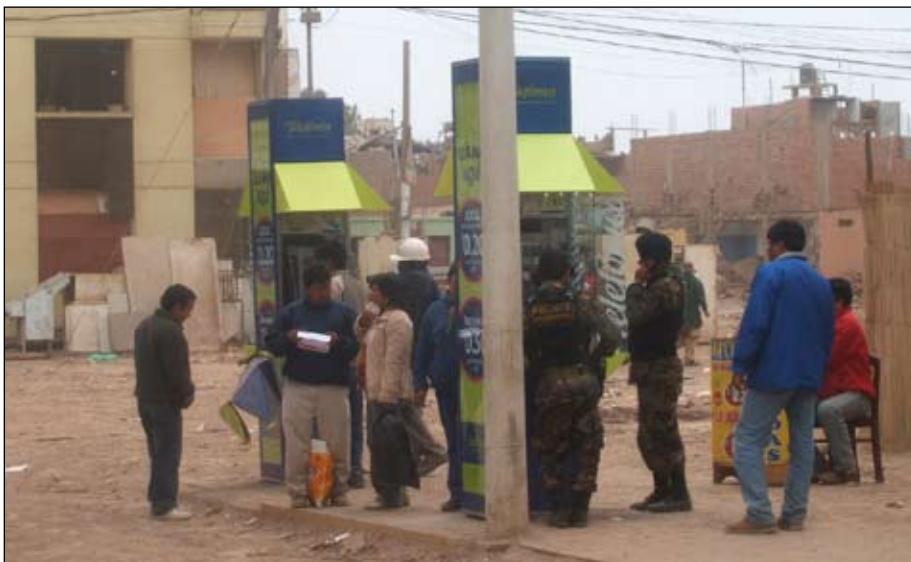
Figure 22. Temporary phone booths were installed for civilian use in Pisco.

Communications: The hardwired system failed, but cell systems were generally functional. In the main town square of Pisco, temporary phone booths were installed for civilian use (Figure 22). After the earthquake severed the electrical power grid, the Pisco hospital started its back-up generators and allowed residents to charge their cellular phones. The hospital also operated by cell phone to coordinate their post-disaster efforts and coordinate their needs with the Peruvian Department of Health.

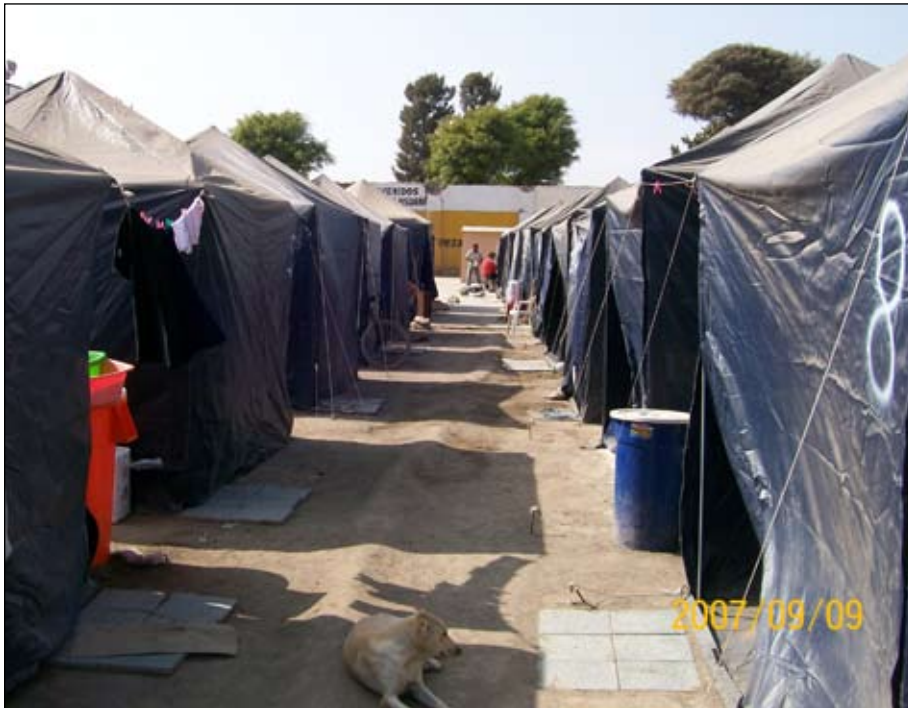
Figure 23. *The largest shelter camp, Albergue Bolognesi, in the city of Pisco.*

of Health, the Brigada Medica Cubana, and the Salvation Army were providing assistance. This camp was well-organized, with numbered tents laid out in rows and “named” streets for walkways (Figure 23). Camp maps, rules of conduct and an organizational chart were posted by the camp’s entrance. Water was available from a central distribution point. Wet rations were being distributed, and it appeared that residents had no other means of preparing meals. Power had reportedly just been supplied to

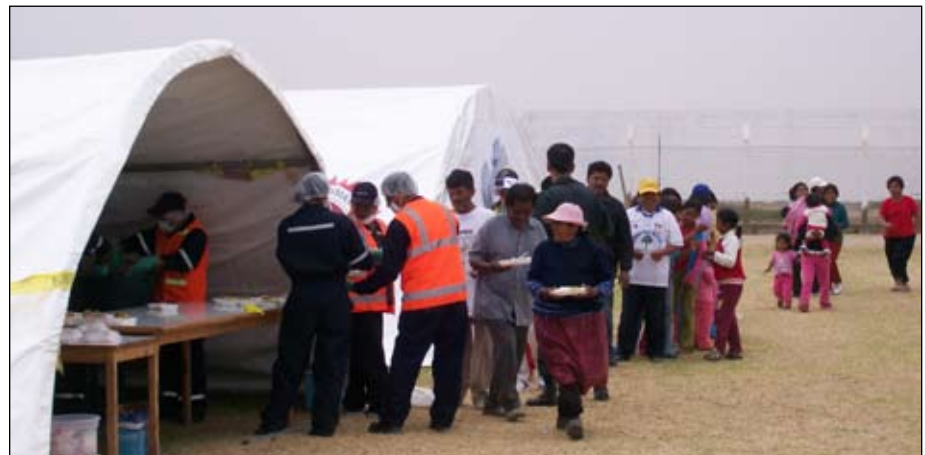
In contrast, the self-organized Albergue Tropical in San Andres (south of Pisco), housing 2500 people from 585 families, appeared to have little external assistance. Two crates of hospital goods remained unopened. Wet rations were provided once a day by a private company (Figure 24), but otherwise food supplies were limited. Power was connected on September 9. The camp had centralized water supply, 23 latrines, but no shower facilities.

Figure 24. *Wet rations were provided once a day by a private company at the self-organized shelter camp Albergue Tropical in San Andres (south of Pisco).*

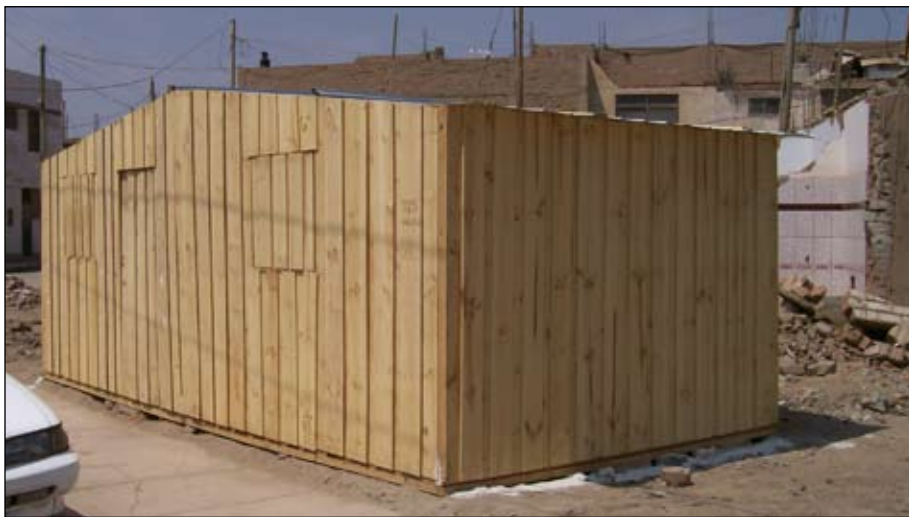
Temporary housing is being provided by the government, to residents that are able to clear debris from their plots. Two types of temporary housing were observed: lightweight wood (Figure 25), or metal frame (Figure 26). The metal frame structures have two rooms, with no plumbing, power, or sewage hook-ups provided. Those observed had no floors, and were open to the elements at the back.

Figure 25: Lightweight wood type of temporary housing.

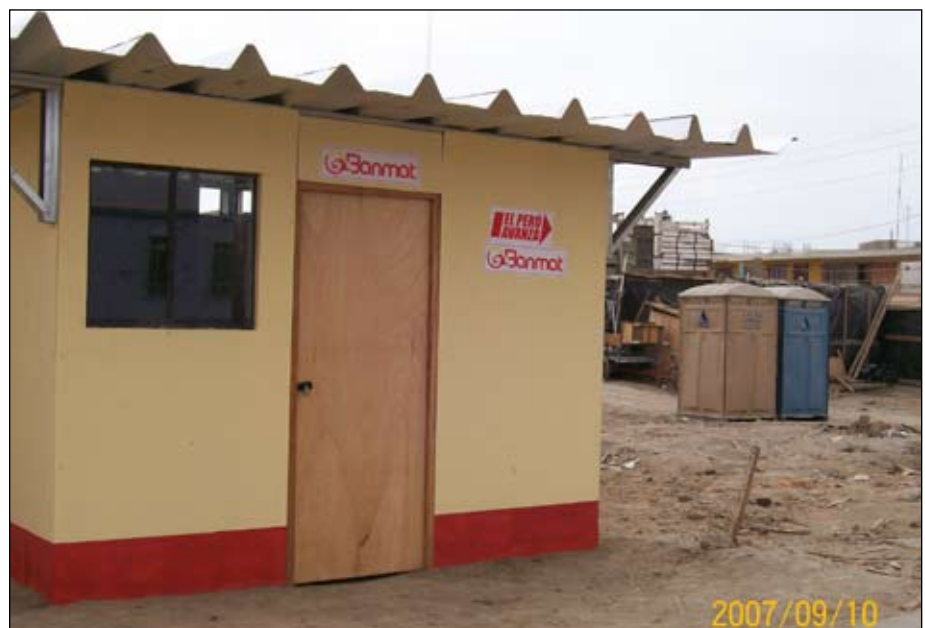
Figure 26: Metal frame type of temporary housing.
